The Front Range Climbing Stewards 1-2 Flatiron Trail Project Report September 9, 2020

Overview

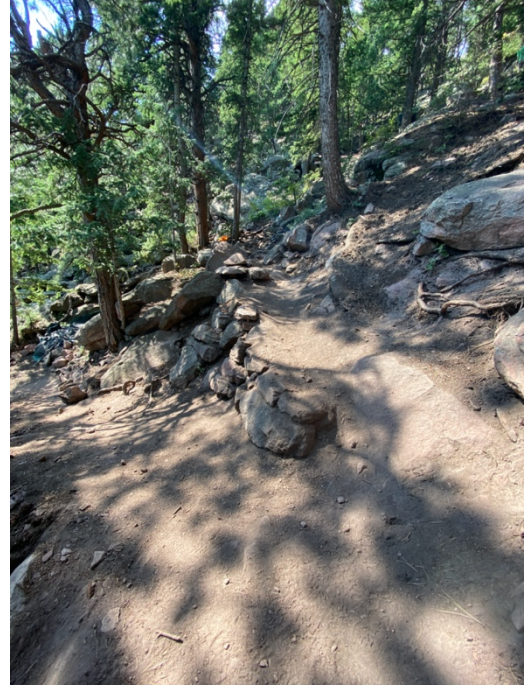
Figure 1: Heavy erosion issues was causing the existing structure to become severely undercut.

The 1-2 Flatiron Trail is one of the most hiked and challenging trails in the OSMP system, being used as a popular destination for views of Boulder and the Rocky Mountains as well as the main descent trail for climbers descending from the 1st and 2nd Flatirons. Due to the terrain in the flatirons, the trail is steep, narrow in various spots and utilizes many switchbacks to gain elevation, and as a result many of the historical trail structures are failing. City of Boulder OSMP has committed a large amount of resources to maintain the 1-2 Flatiron Trail over the years, having a 5-person trail crew working exclusively on the trail seasonally since 2016. For 2020, the FRCS crew was tasked with rebuilding in place one of the preexisting switchback turns that was becoming severely undercut and eroding (**Figure 1**).

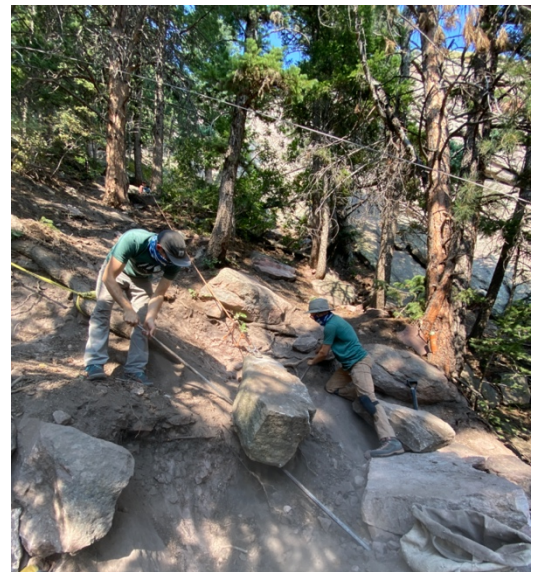
Figure 2: FRCS crew using a belay system to lower a large rock down onto the worksite.

Due to the steep terrain on this trail, and lack of available stone material near the work site, FRCS chose to quarry uphill from the site and utilize a high line rigging system to transport stone safely. By using a high line system, FRCS was able to aggressively quarry material out of sight from the trail, lowering their visual impact, and transport the stone without the risk of dislodging a rock on the hillside that could potentially tumble down the hill. In addition to the high line system, FRCS used traditional tools such as rock bars and a belay system to maneuver larger material down to the worksite (**Figure 2**).
