## 2021 Avalon Climbing Area Access Stabilization Project Phase 1

### Overview

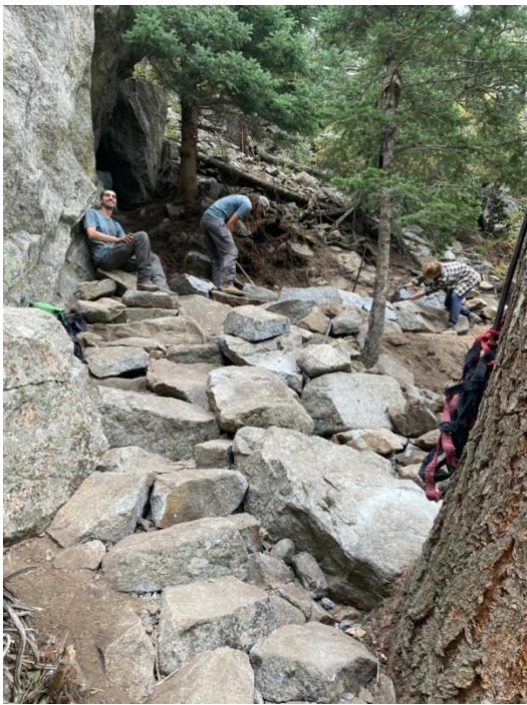
**Figure 2:** Stone structures were built to facilitate the trail and prevent erosion of the hillside.

For the Phase 1 portion of the Avalon Climbing Area Access Stabilization project, BCC's trail crew worked 4 weeks in the Avalon Climbing Area. The goal was to address the erosion issues approaching and at the base of Middle Wall at Avalon. This area hosts the largest concentration of highly rated routes and is often the most trafficked area at the crag. The work consisted of creating

durable stone structures such as retaining walls, staircases, and belay pads from locally sourced material (**Figure 2**).

At the end of the project, 135 linear feet of durable and sustainable trail were built, including 185 ft<sup>2</sup> of retaining structure and installation of 80 stone steps. Please see the Avalon Climbing Area Access Stabilization budget in **Appendix A**, full Work Metrics Section in **Appendix B** and additional before/after photos in **Appendix C**.

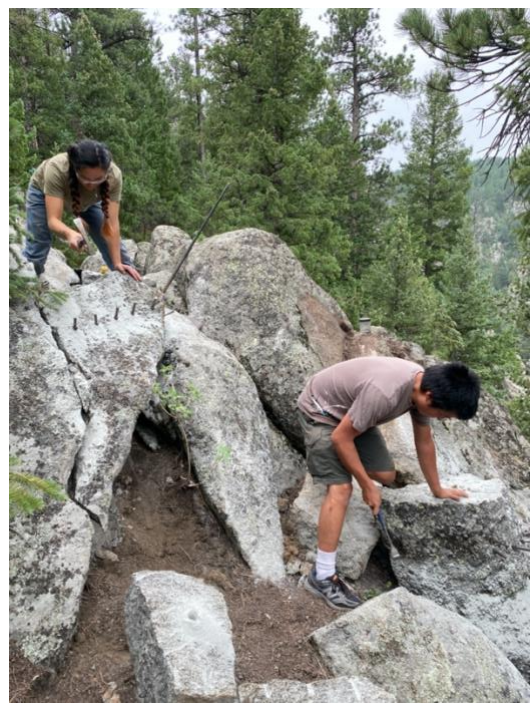
**Figure 3:** Volunteers learning to quarry and split stone.

While BCC's trail crew was responsible for much of the technical construction, another goal of this project was to get the local community involved. Two weekend stewardship events were hosted for volunteers to come out and work alongside our trail crew, learning valuable stewardship and trail building skills (**Figure 3**). In total, BCC accumulated 181 volunteer labor hours during this project.
