Boulder Canyon Climbing Access Stabilization Project: Avalon

Overview

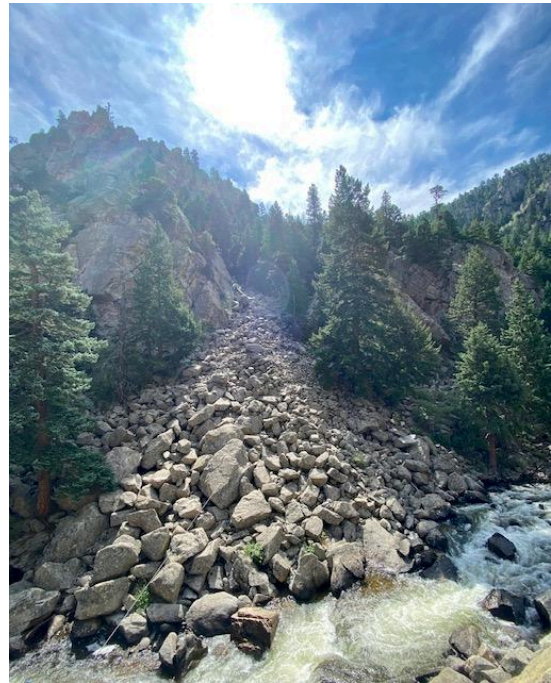
Figure 1: Talus field leading up to Avalon

The original climbing access trails in the area were not designed for sustainable use, and were rather, the most direct path to the climbing destination. Taking this into consideration and adding the steep grade of the terrain along with the loss rocks located in the lower talus field as seen in Figure 1, much of the access trail and base areas beneath the climbs were in poor condition. There were heavy erosion issues and the trail was unsustainable for current and future use.

In 2023, the BCC finished the final phase of the Avalon project after eight weeks of work. This last section of trail went from the base of the tirolien traverse up to the previous work done in Phase I and II. All work done in Phase III was constructed in a step and loose talus field as seen in Figure 1. The BCC trail crew cleared a path for the trail through the talus field while stabilizing large hazardous rocks. After stabilizing the rocks in the talus field, the tread for the trail was constructed, often using the large talus rocks as part of the trail. With a clear path and obvious stone steps leading through the talus field, hikers can now easily find their way without scrambling on loose rocks. The BCC also received in kind help from the Rocky Mountain Conservancy (RMC) during this phase in partnership with the USFS. BCC staff helped train and mentor these crew members in rock quarrying and intensive stone work. The BCC had exceptional turn out with volunteer and corporate group trail days.

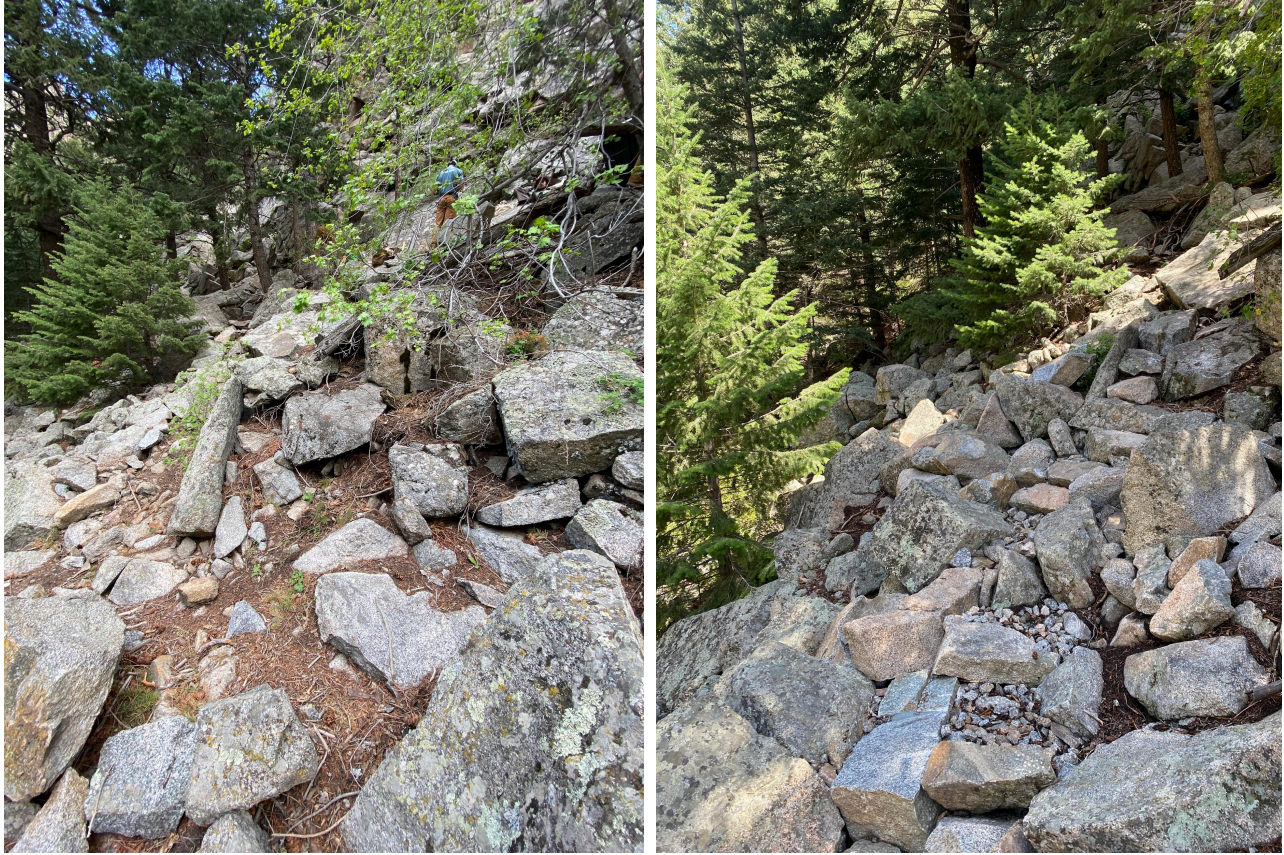
Figure 3&4: Stone steps and tread with retaining structure heading up through some more stable talus. (Phase III)

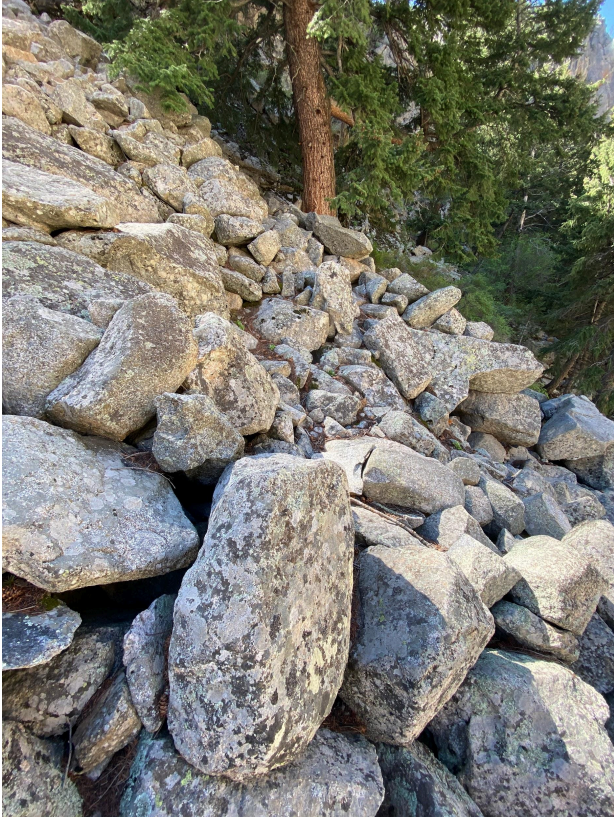
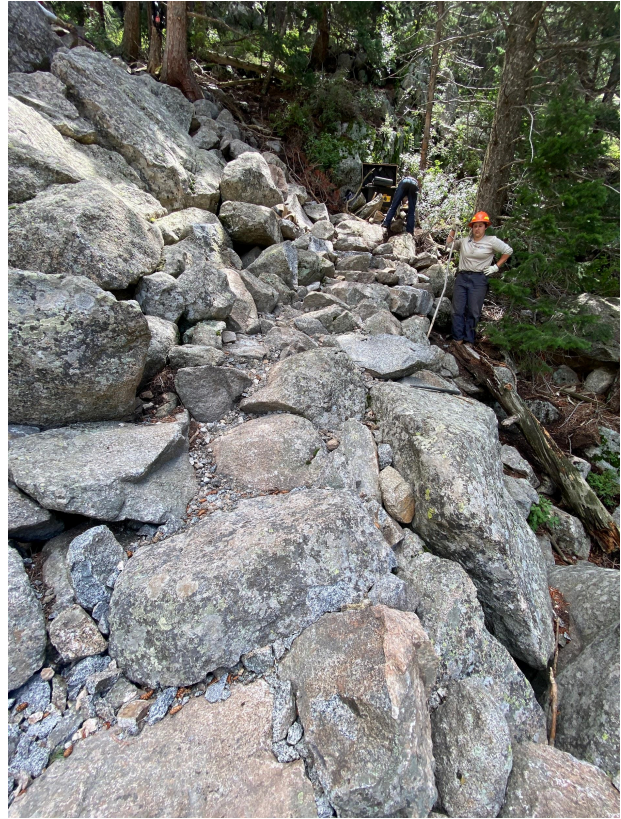
Figure 5&6: Tread created through the upper talus field via shifting large rocks to a stable position. (Phase III)

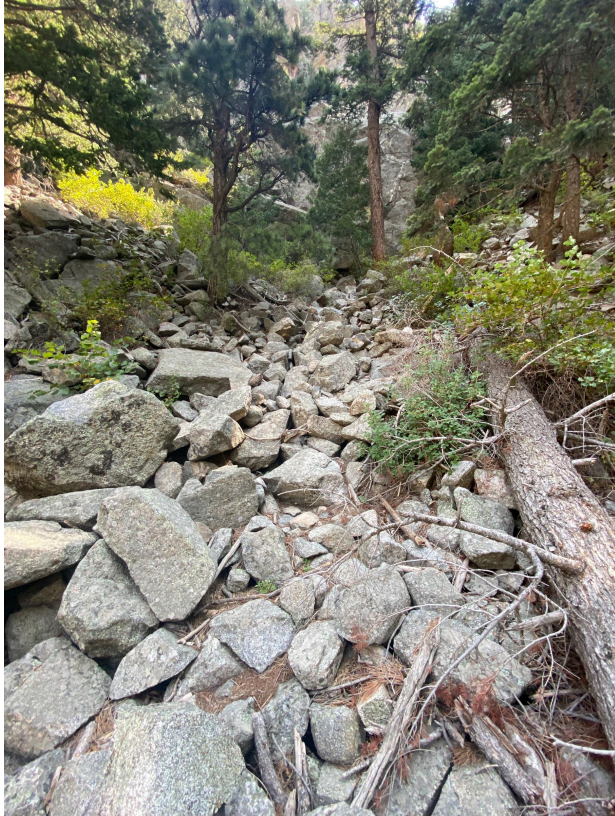
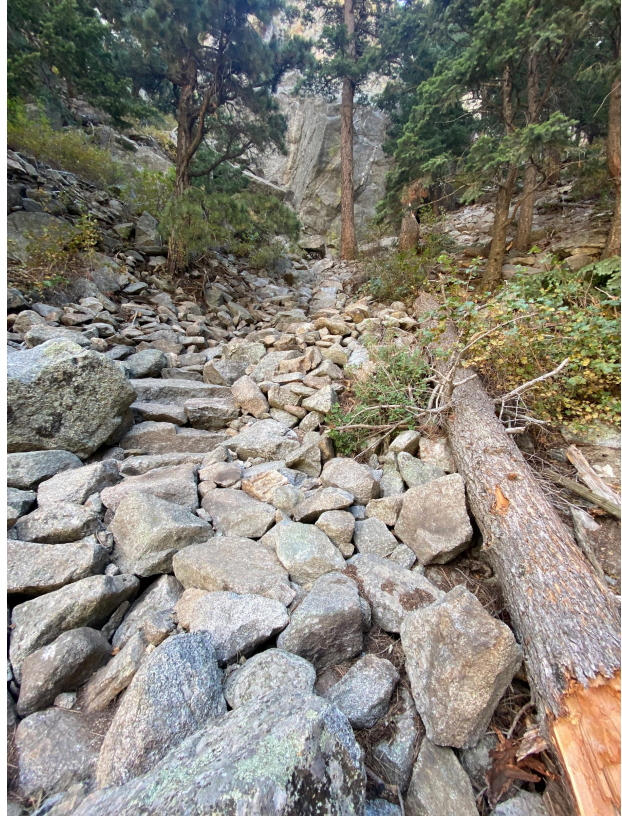
Figure 7 & 8: Stone staircase leaving the top of the talus field heading towards Middle Wall. (Phase I)

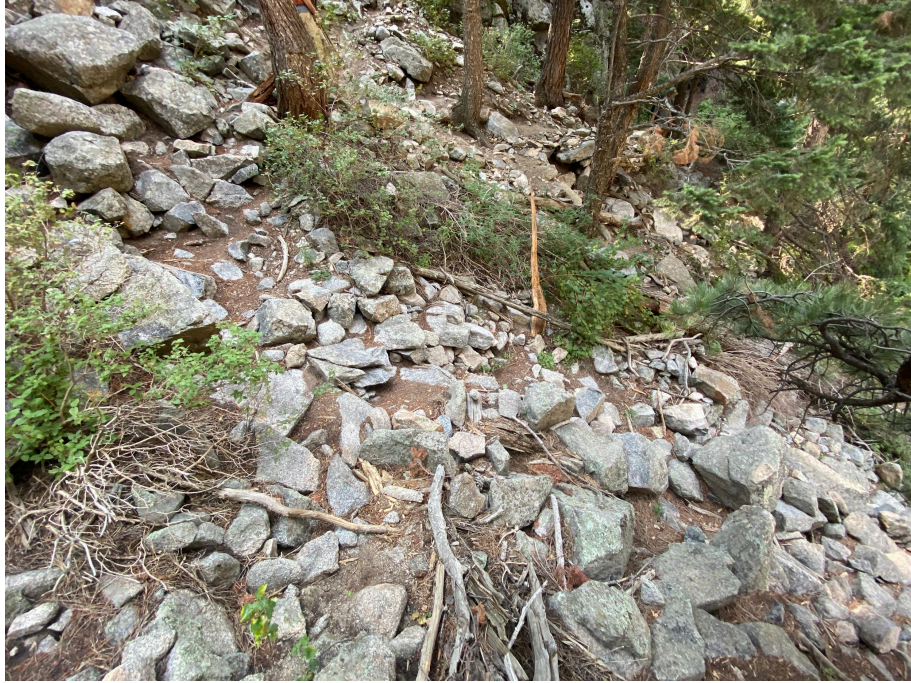
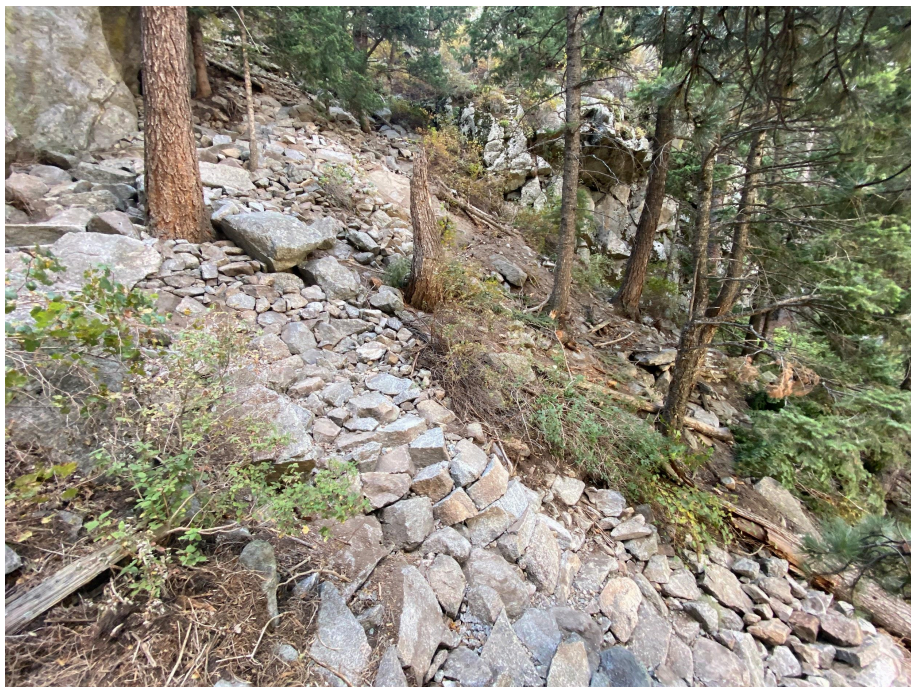
Figure 9 & 10: Staircase with retaining structure heading to Middle wall. (Phase I)

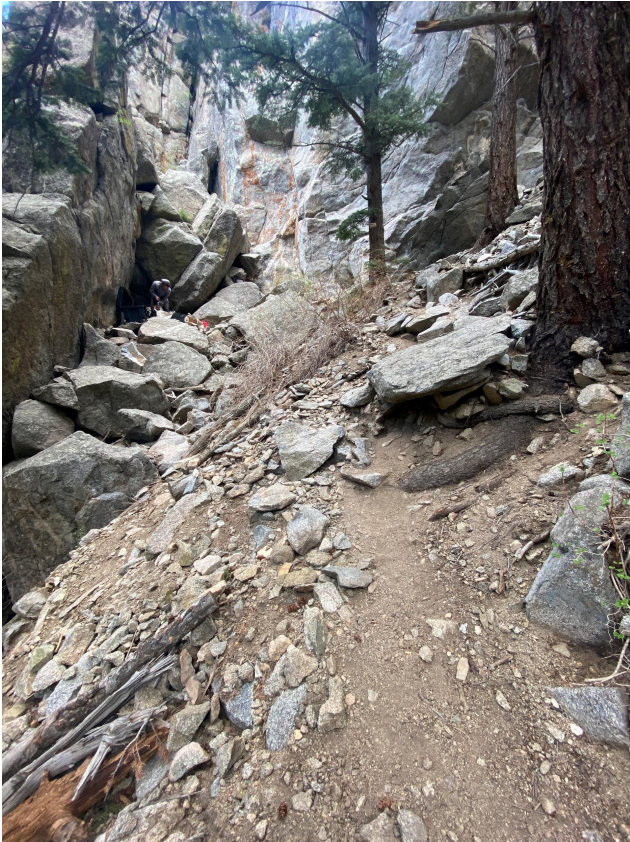
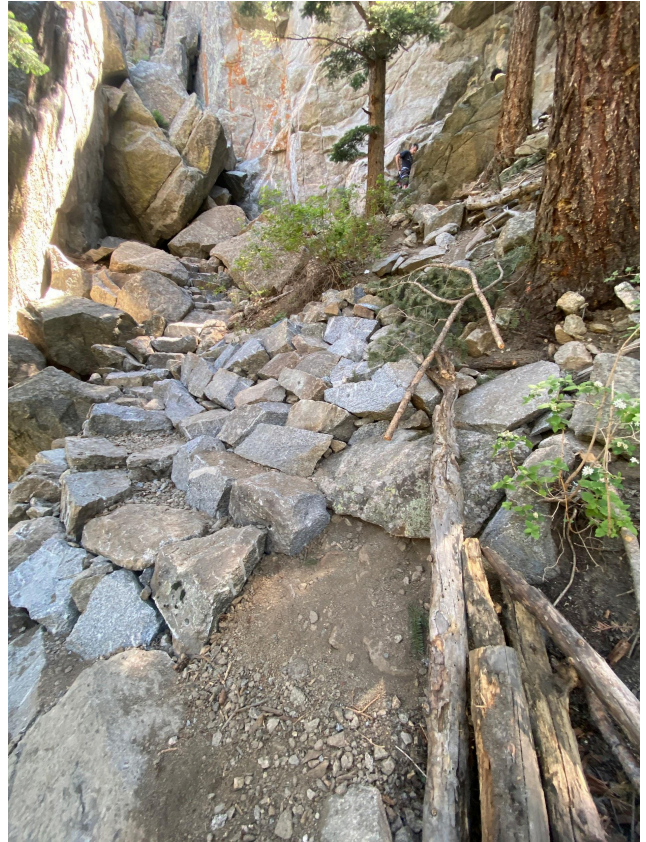
Figure 11 & 12: Heavily eroded trail up to the main wall at Avalon. A large retaining wall with the trail running through it was built to stabilize the trail and hillside while diverting the main trail to a more stable surface. (Phase II)

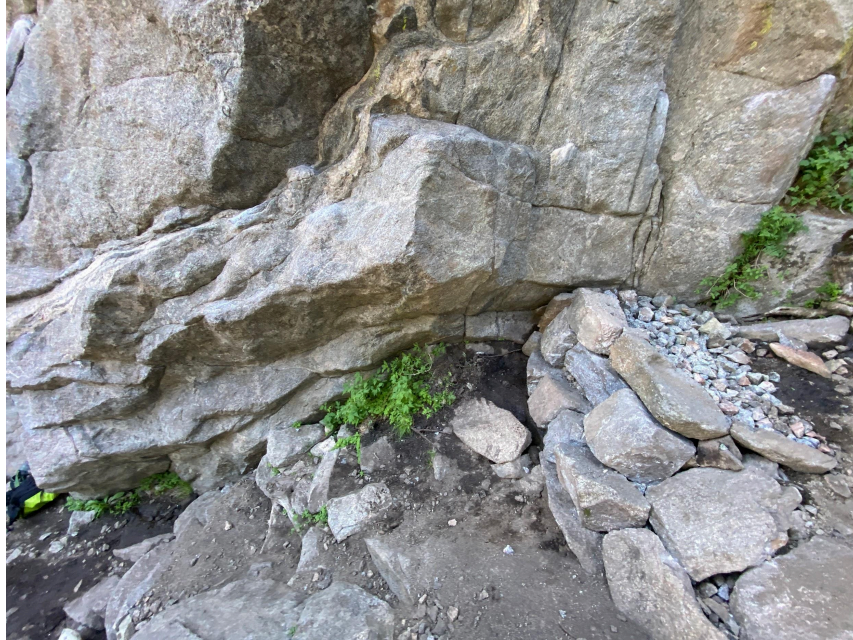
Figure 13: Belay Pad built under a popular climbing route. (Phase II)

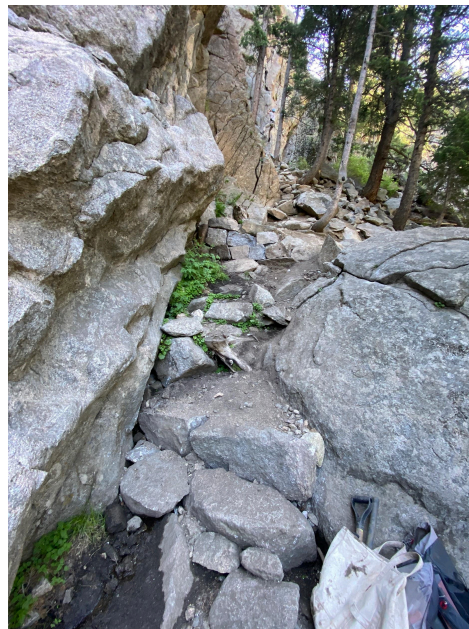
Figure 14: Belay pad with retaining structure built to protect the base of the popular Climbing Route Strange Science 11c. (Phase II)
