# The Front Range Climbing Stewards Castle Rock Overlook Project Report (Platt-Rogers Memorial Open Space Overlook Project IRFQ 2030-20) August 4, 2020

## Overview

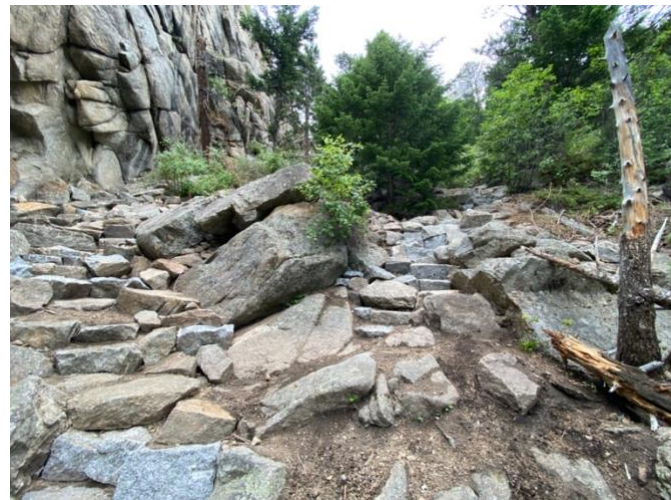
*Figure 1- Construction of a primary path (Right) with an alternative path (Left) that leads to the climbs at Broken Rock.*

In 2019, FRCS and BCPOS agreed upon a strategy of restoring the primary social trail in place by hardening the surface of the trail with natural stone. In 2020, FRCS continued the work from the previous season, building one primary path out of stone, while also providing hardened off shoot trails that access the climbing routes that run along the trail (**Figure 1**). This work included quarrying stone (**Figure 2**) from a talus field 200 ft to

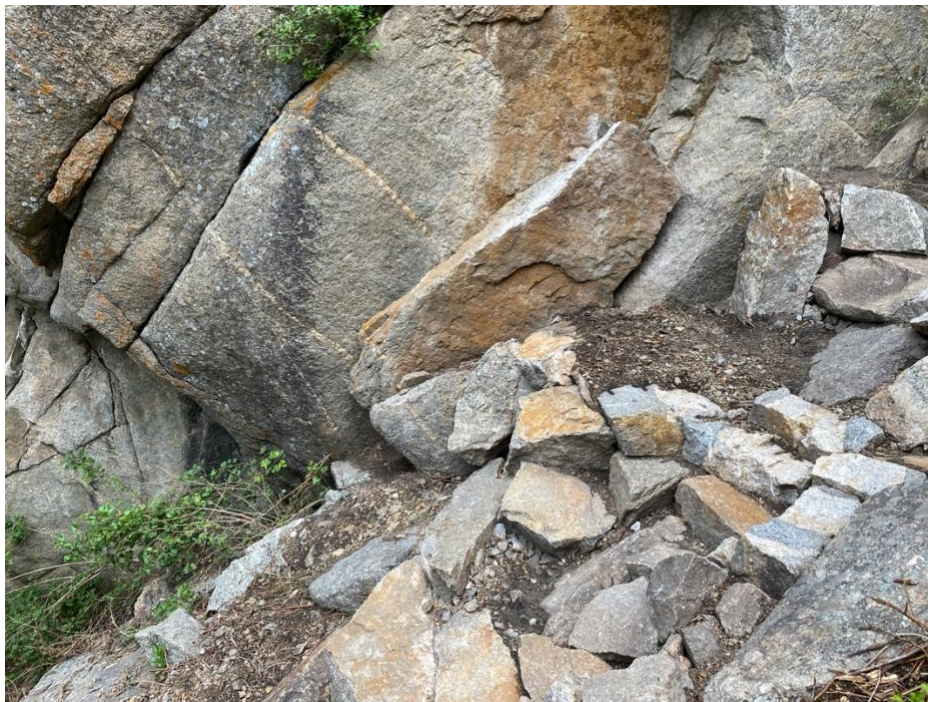
*Figure 3- Construction of a belay pad, providing a sustainable and flat area to stage and climb from.*

the west and transporting it via a highline system, constructing stone staircases, retaining structures and belay pads (**Figure 3**), as well as restoration of existing social trails. The labor and planning for this project can be found in **Appendix A**.

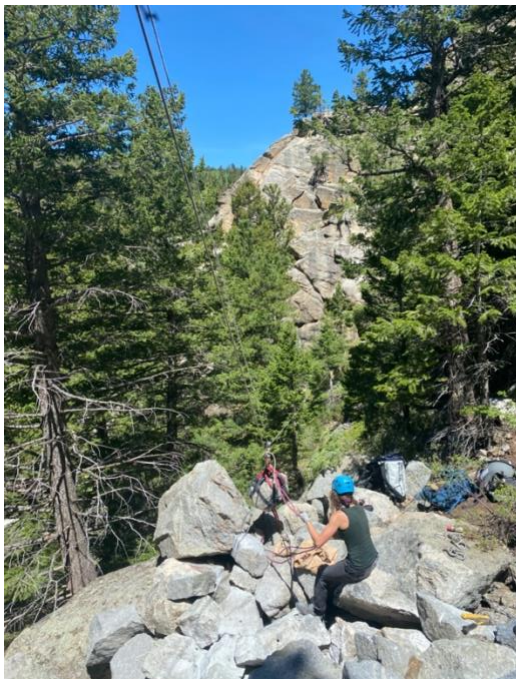
Figure 4- FRCS staff utilizing the highline system to transport material

COVID-19 also affected FRCS' ability to utilize large volunteer groups to help with the transportation and gathering of material. For reference, in 2019 volunteers provided 439 labor hours to the Castle Rock Overlook project and were instrumental in its success. In order to still utilize individual volunteers under the states COVID-19 guidelines, FRCS utilized rigging and a highline system to safely social distance while transporting material to the worksite (**Figure 4 and 5**).

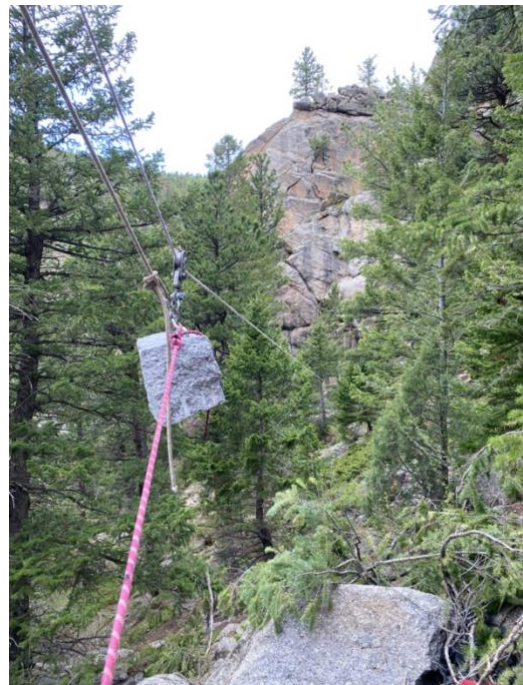
Figure 5- Material being transported via the highline.

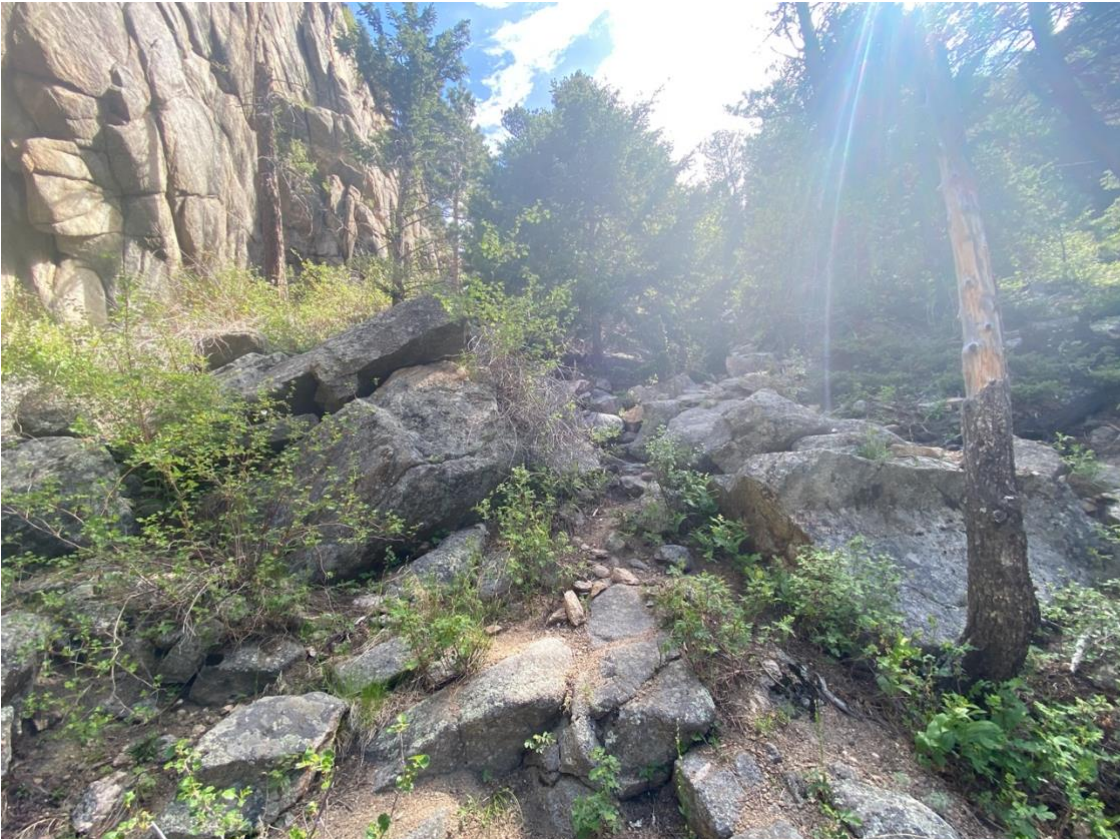
*Before: Various trails split at this junction.*

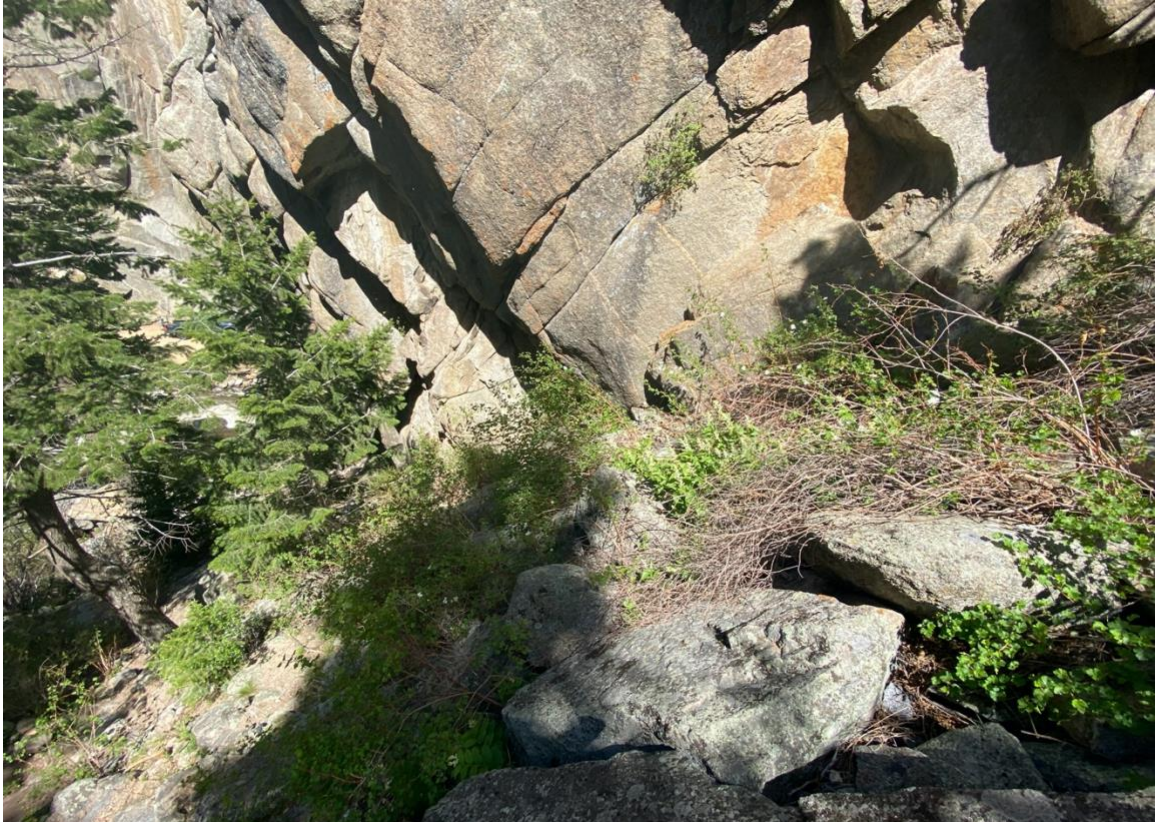
*Before: Access to the climbs on Broken Rock was overgrown and not obvious or comfortable to belay from.*

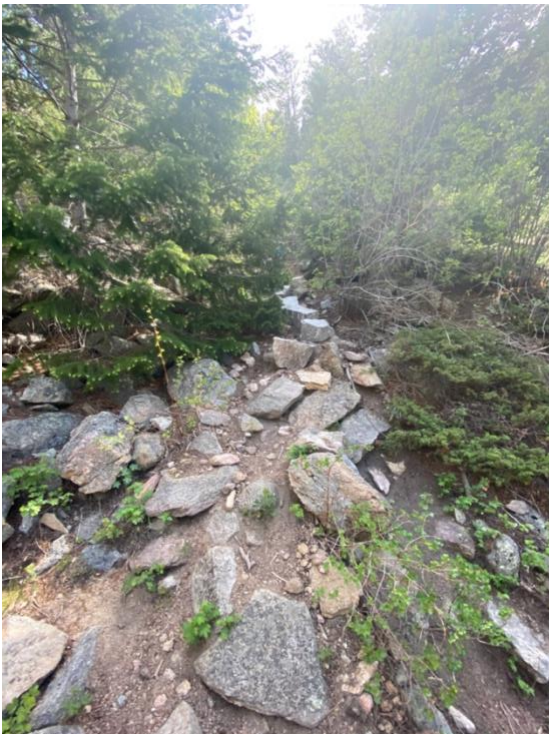
*Before: Erosion on the primary user trail*
