The Front Range Climbing Stewards

Castle Rock Overlook Project Report

(PLATT-ROGERS MEMORIAL OPEN SPACE OVERLOOK PROJECT IRFP# 2020-19)

July 3rd, 2019

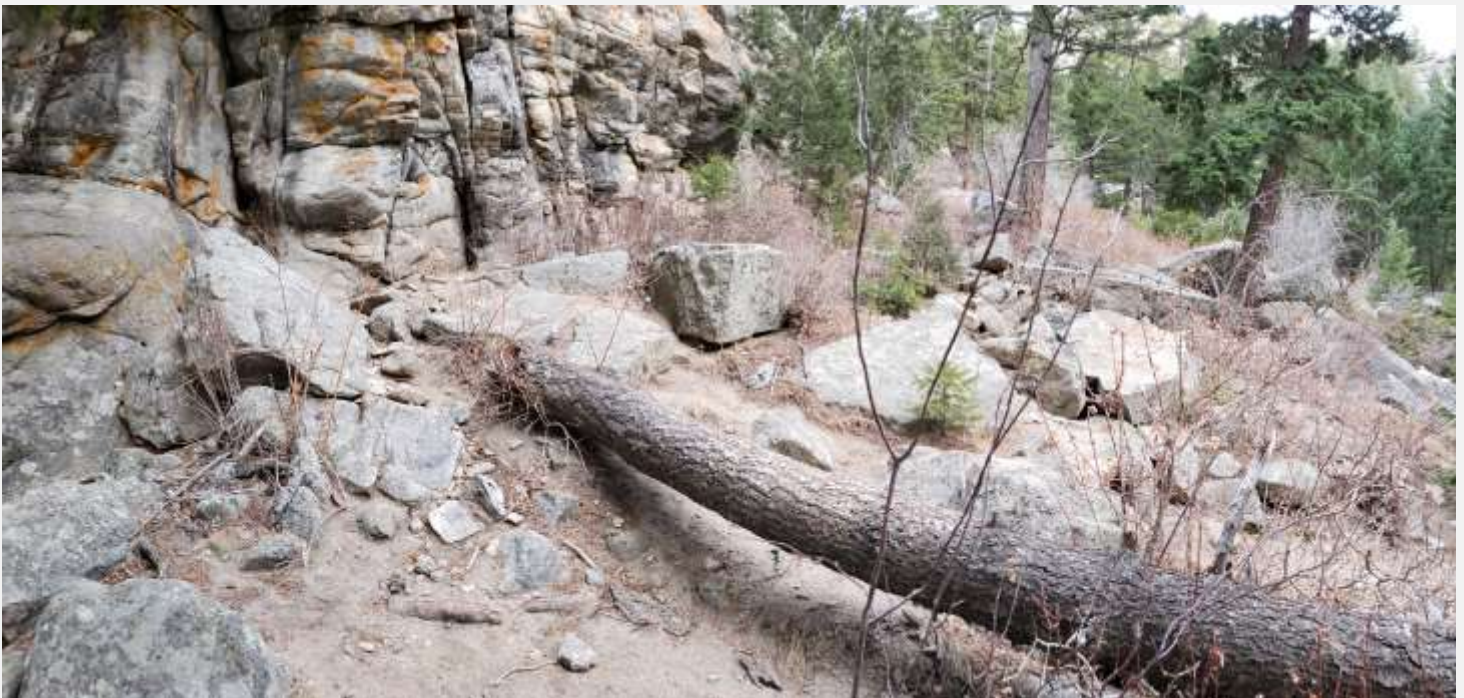
Figure 1 - eroded and braided hillside of the area

The social trails that access this area located immediately above S. Boulder Creek are braided and heavily eroded (**figure 1**). BCPOS and FRCS agreed upon a strategy of restoring the primary social trail in-place by hardening the surface of the trail with natural rock. Stone in the immediate area was arranged and built to accommodate the use while preventing erosion and discouraging trail braiding. Attention was paid to how precipitation and humans erode the area and the design of the structures look to offset these factors.

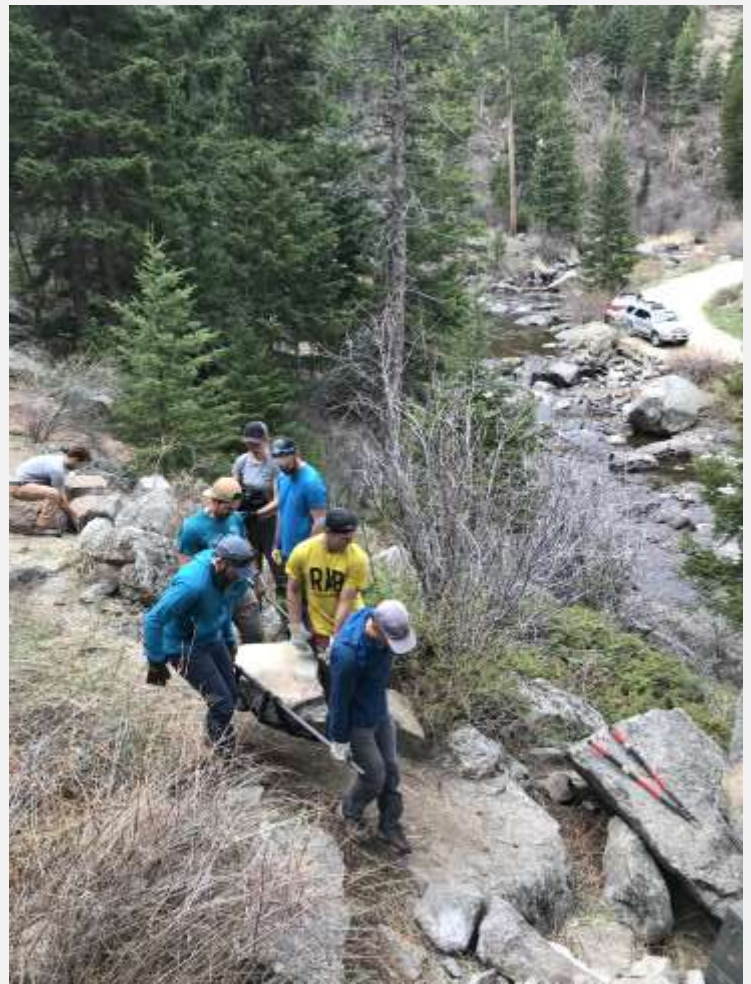
Figure 3 - Volunteers from Rab transporting the stone material

Due to the incline of the slope the stone in the immediate area was not enough to build sufficient structure for this purpose. Rock from a quarry approximately 200 ft to the NW was quarried into suitable size and shape (**figure 2**) and transported (**figure 3**) to the worksites on the trail.

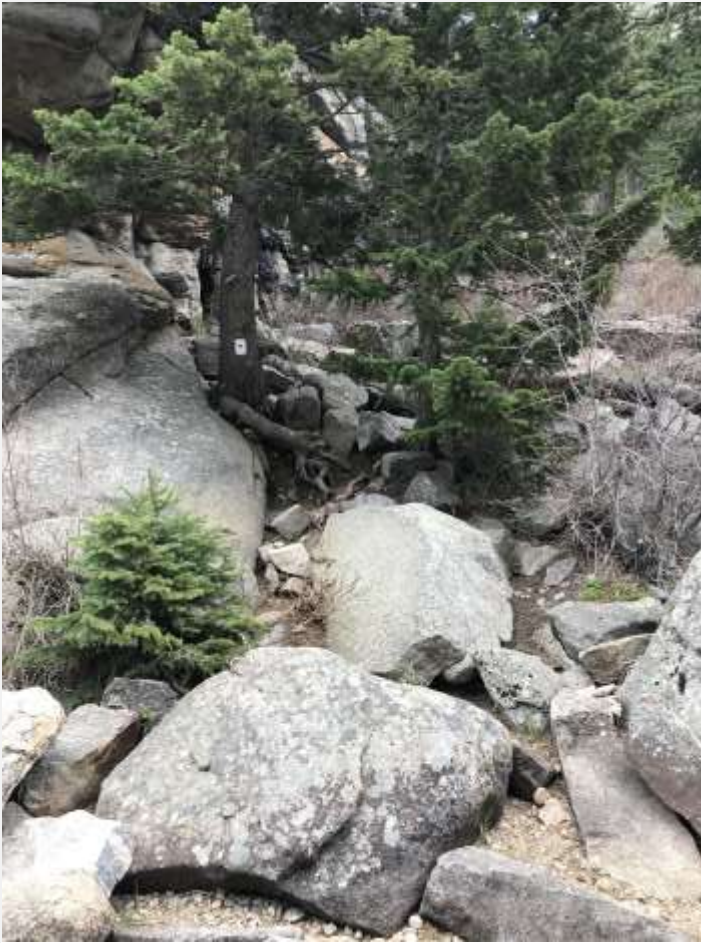
Figure 4 - Eroded slope above creek bed (Before)

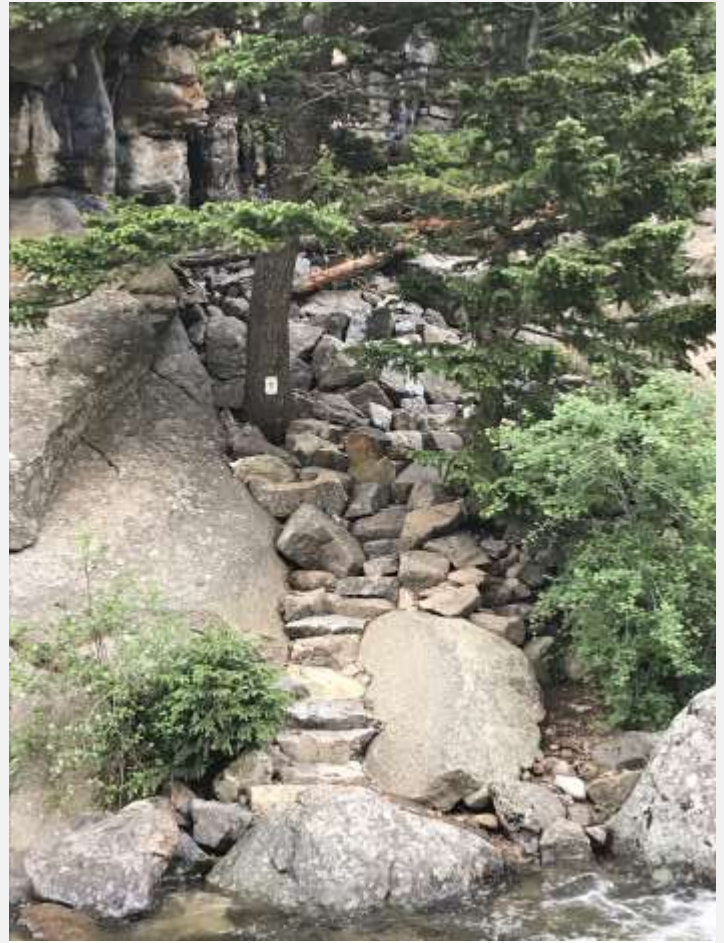
Figure 4 - Erratic, yet functional steps/structure at start of trail (After)

One significant parameter attached to this project was that the initial trail section that is seen from the bridge be unobvious in nature so as to not attract more users to the area. The idea being that those who have already chosen to travel in the area will naturally find the coherent path to follow but that the existence of some classic and obvious man-made structure would instead attract more users to the area. This was accomplished throughout the entirety of the project with a building style that mimics the erratic nature of rock talus instead of the classic stonework that you may find at a trailhead or park. This approach was particularly used at the beginning of the trail where it is most visible from the road (**figure 4**).

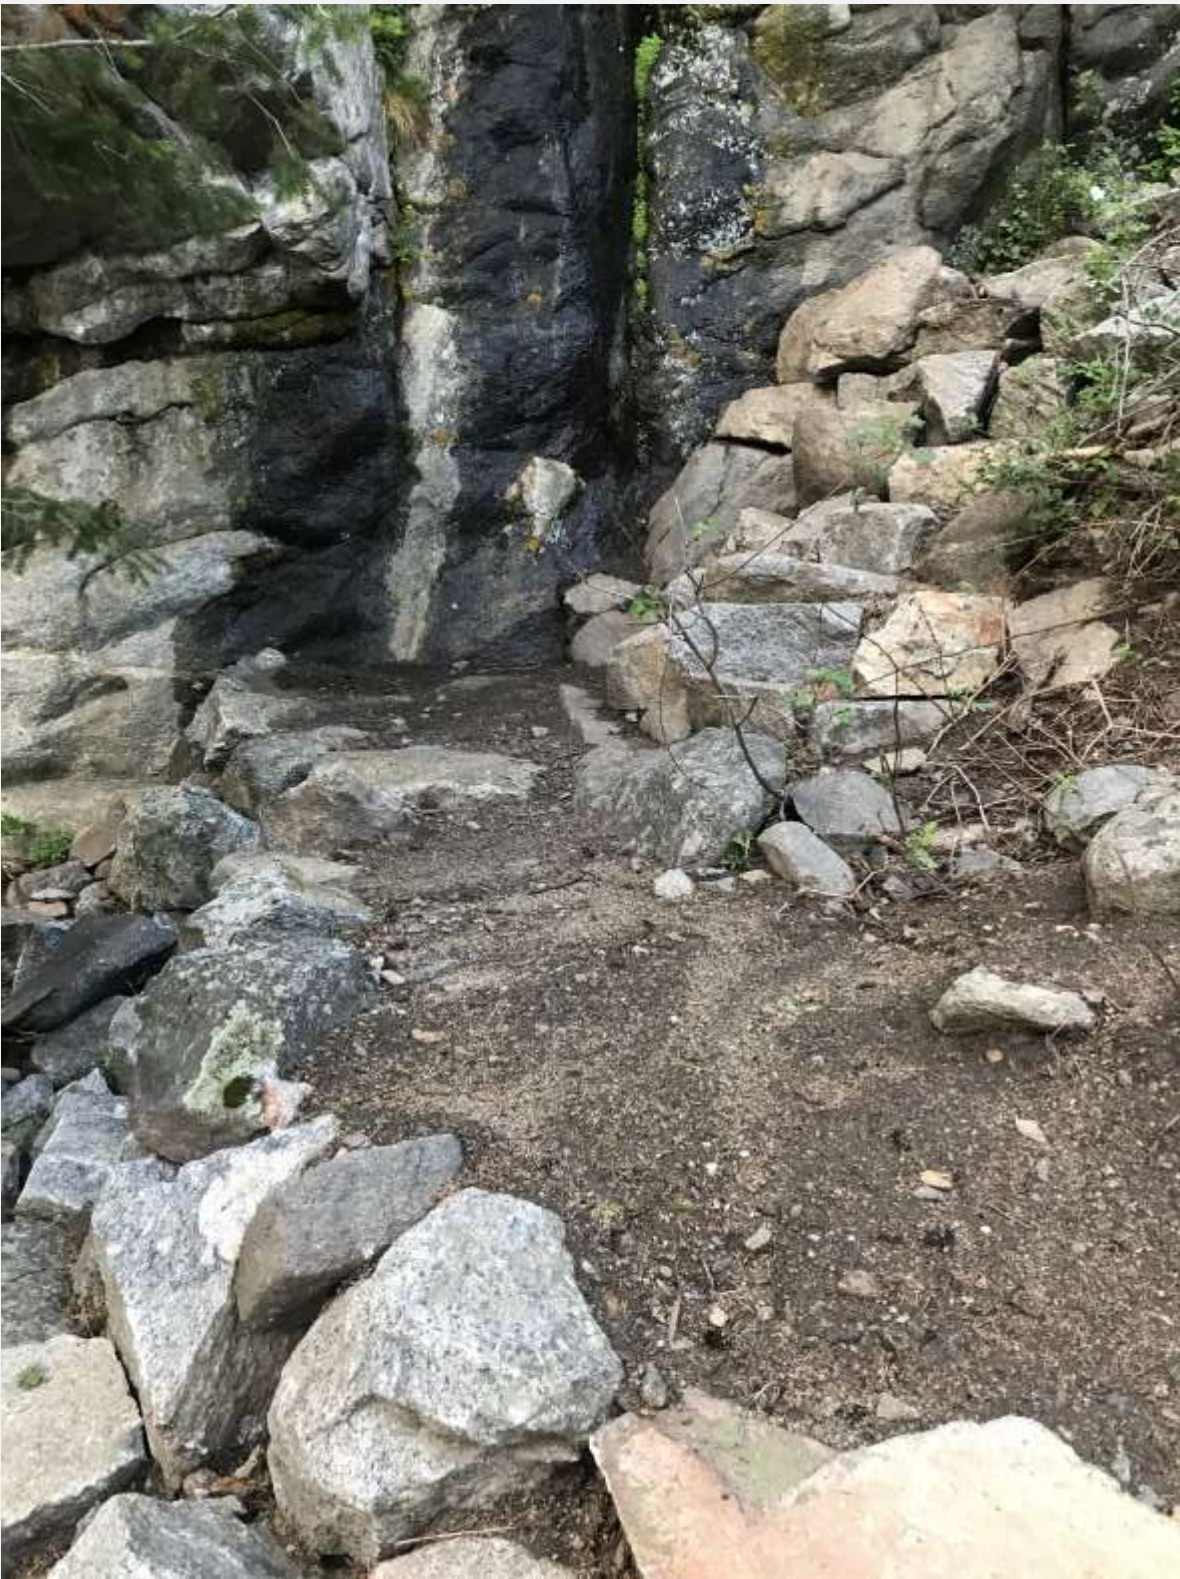
Figure 5 - Belay staging areas constructed at the base of climbs

trail to ensure that this use not congest and divert the traffic on the primary trail. This can generally be understood as side access trails and staging areas much like picnic sites off of a main trail but in this steep terrain involve significant retaining structure and considerable stone steps. These structures were also built in an erratic style resembling the natural surroundings (**figure 5**).

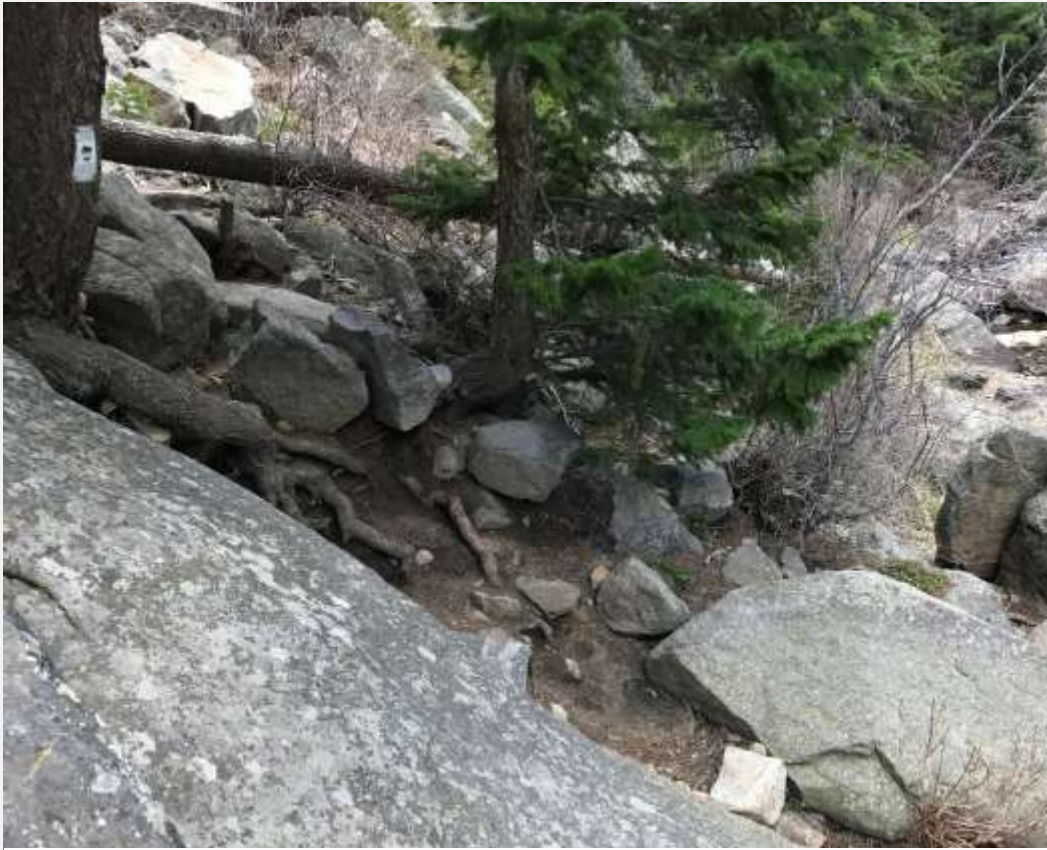
Eroded Trail/Streamside slope - Before

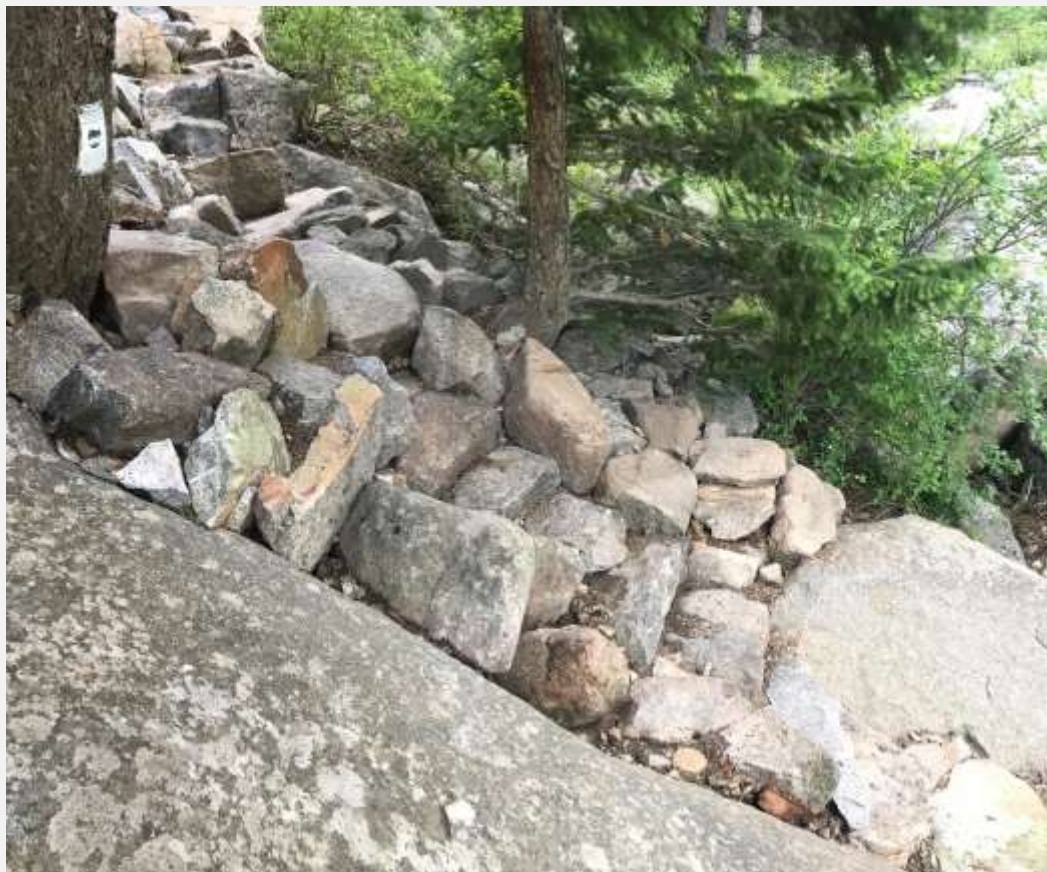
Eroded Trail/Streamside slope - After

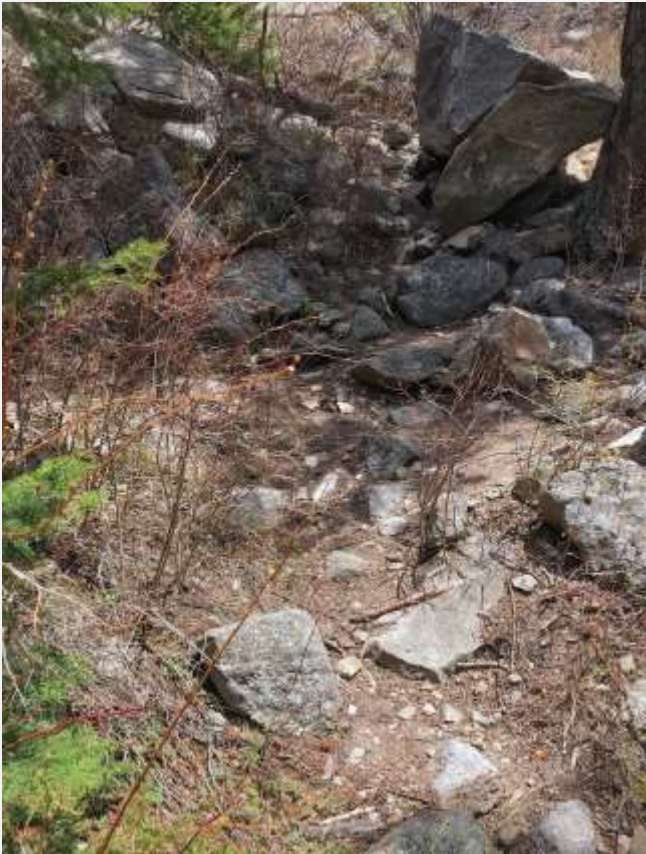
Eroded Trail; Section A - Before

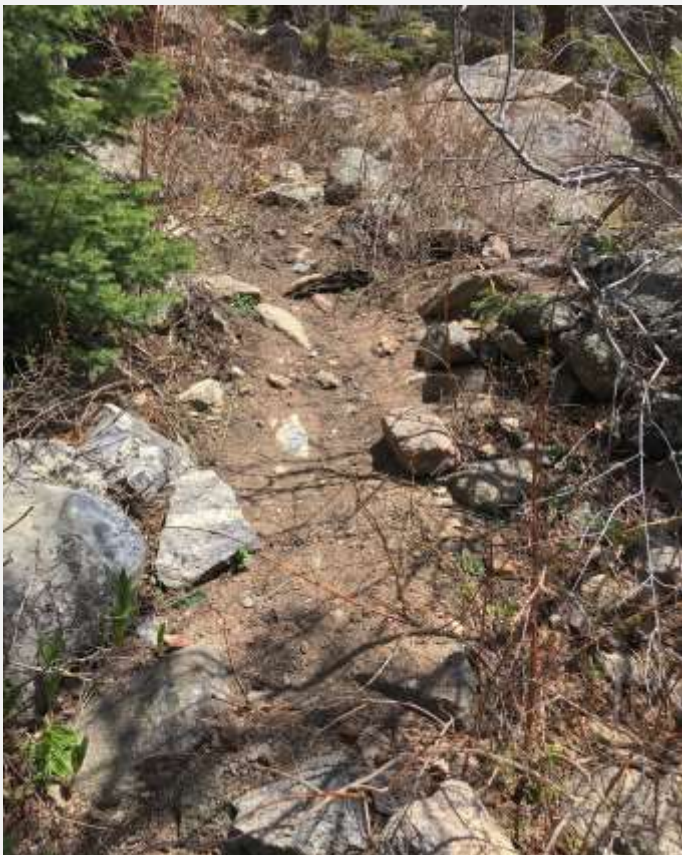
Eroded Trail; Section B - Before

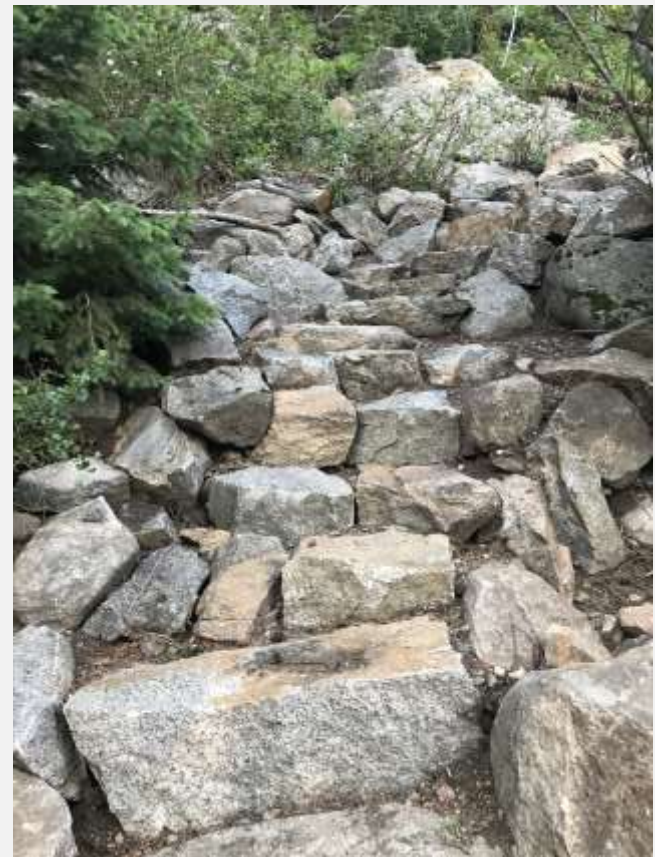
Restored Trail; Section B - After

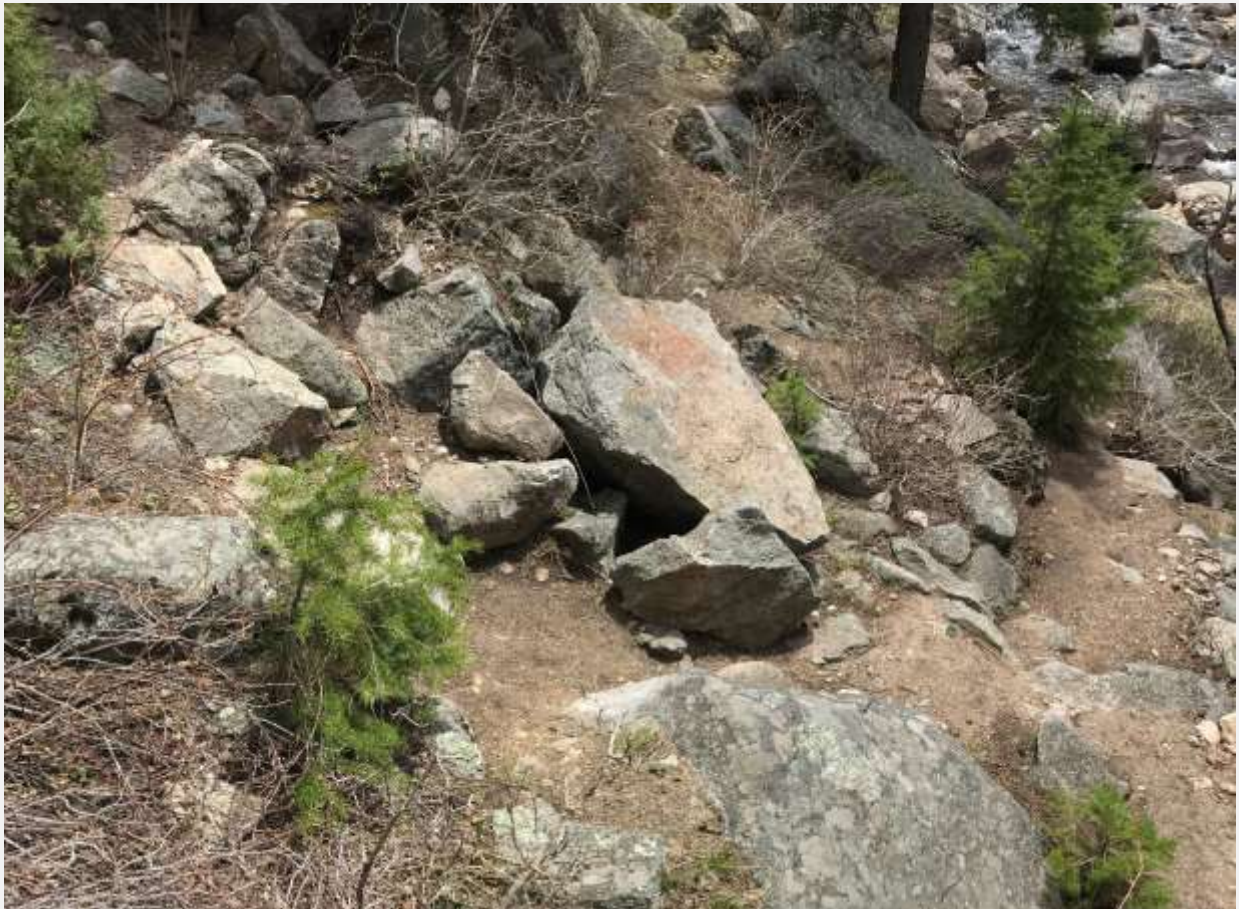
Eroded Trail; Section C - Before

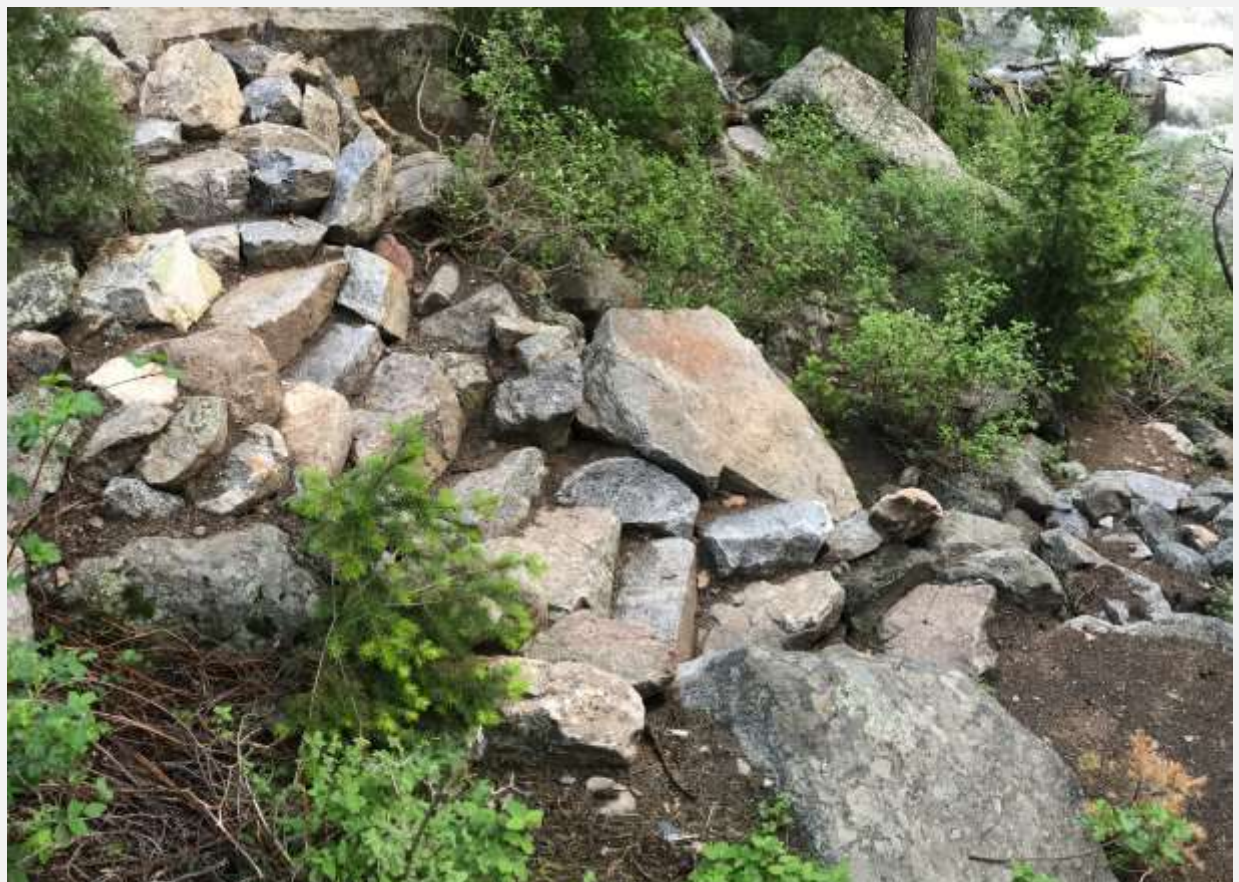
Restored Trail; Section C - After
