Lower Tiers of Zion Golden, Colorado

Overview

Project Synopsis

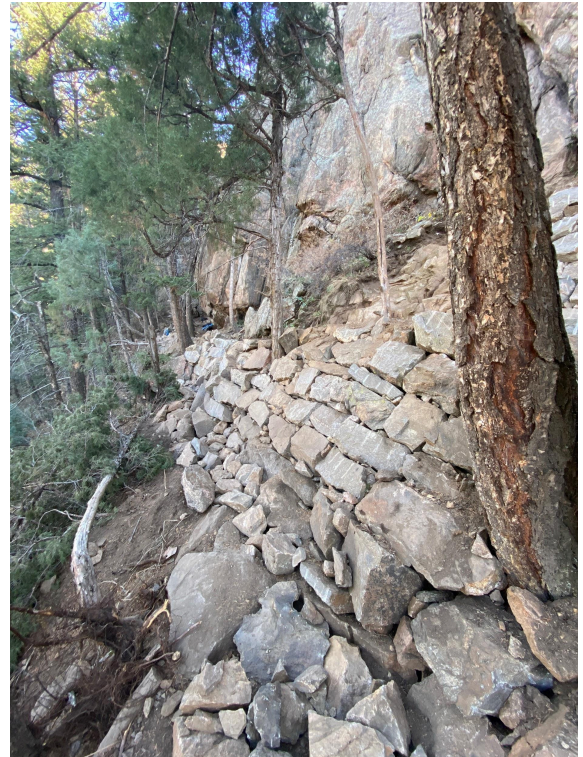
Figure 1: 20 ft long retaining wall

The BCC had two main objectives divided into four separate worksites for this project. The two objectives required a large amount of stone material to build structures. For objective one, the BCC constructed a 20-foot long retaining wall supporting the trail leading to the far right side of the crag as seen in Figure 1. A belay pad was constructed below one of the most popular routes, Three Little Birds 5.9, as seen in Figure 5. For objective two, the BCC constructed a belay pad underneath the climbing route Buffalo Soldier 5.10c and reinforced the trail underneath the route. The BCC also constructed a staircase in the gully leading to the routes on the East Wall, or the far left wall of the crag. A large retaining structure was also re-constructed underneath the East Wall climbing routes.

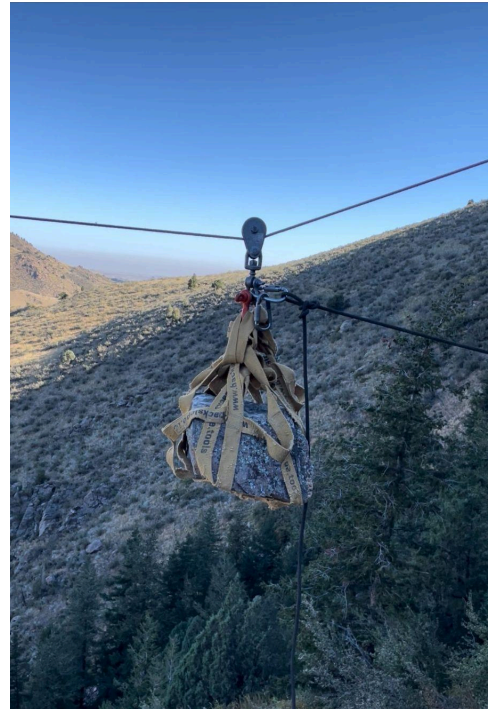
Figure 2: Rock loaded up in the BCC's highline rigging system.

Due to the nature of this area, all rock material was located over 100 feet away and down a steep slope. A total of five highline rigging and hauling systems were utilized to transport materials over large distances as seen in Figure 2. Not only did these highline systems make gathering materials easier, they also reduced the environmental impact on the surrounding area.

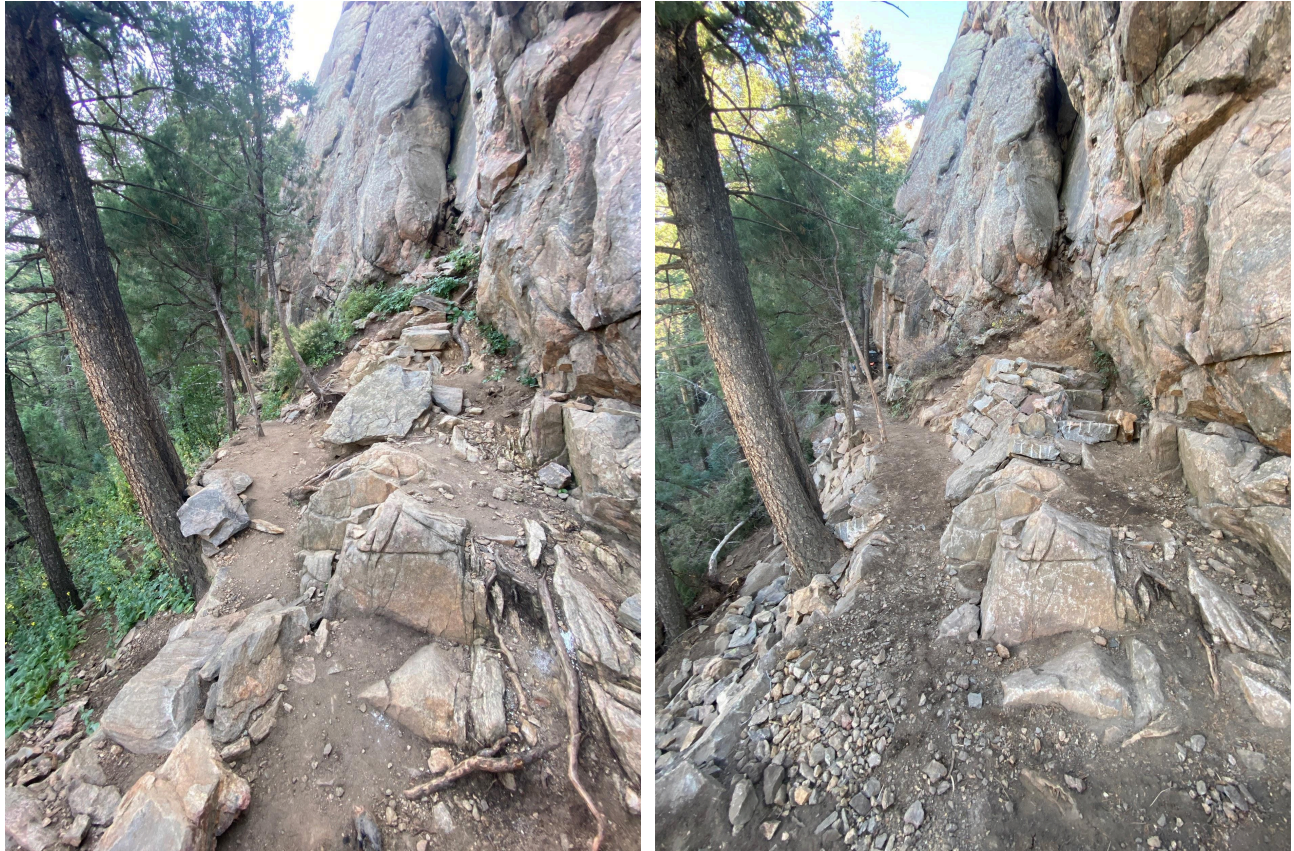
Figures 4 and 5: Eroding trail and loose belay pad (left) turned into a durable trail supported by a stone retaining wall and a sustainable stone belay pad for Three Little Birds 5.9 (right).

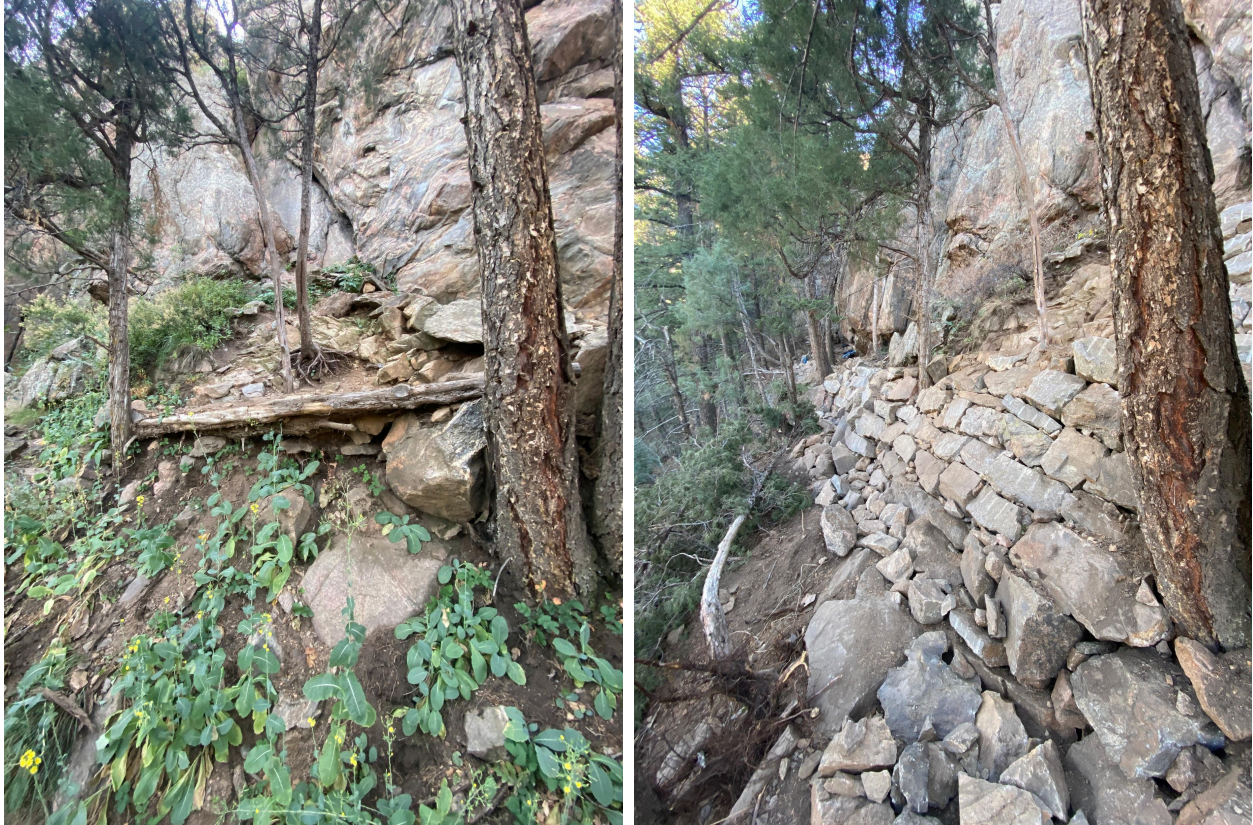
Figures 6 and 7: Old trail held up by a singular dead log (left) replaced with a large stone retaining wall (right).

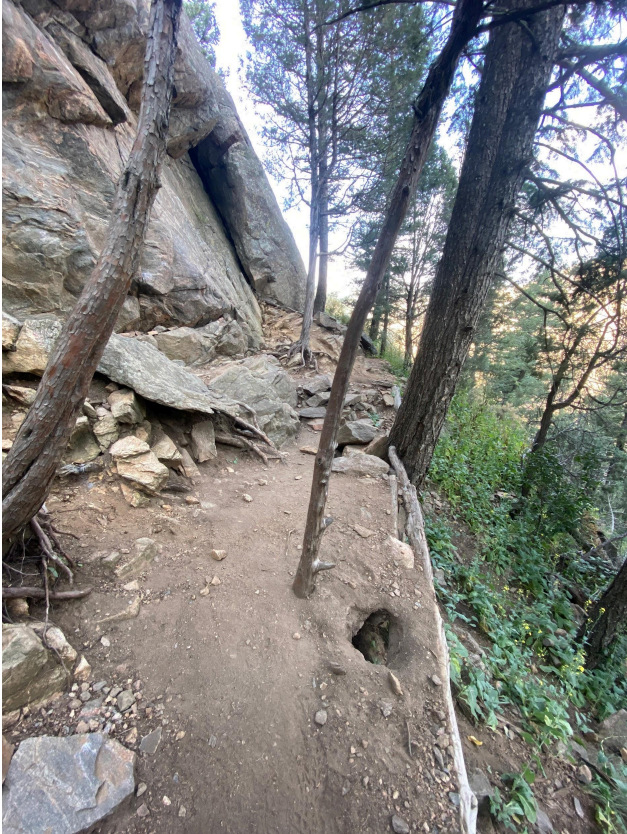
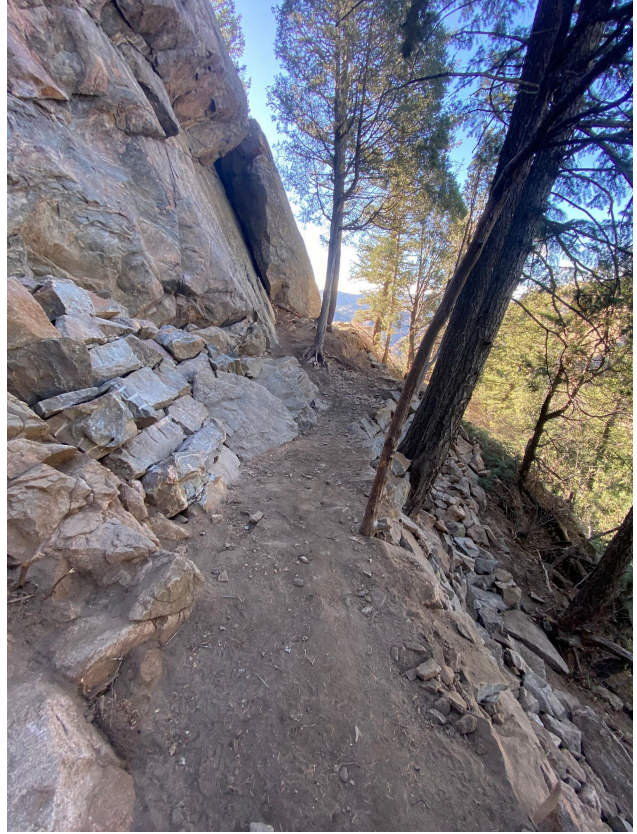
Figures 8 and 9: Same structure as seen from above in Figures 6 and 7.

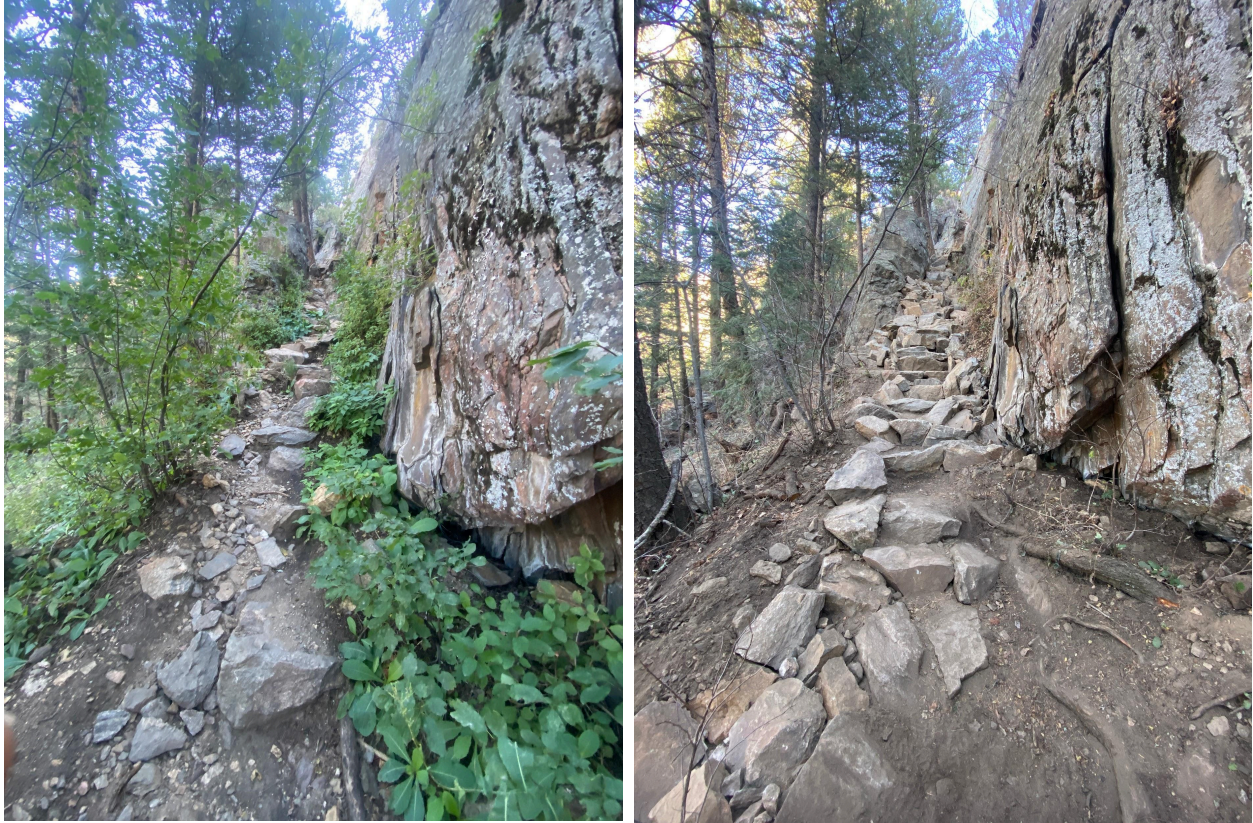
Figures 10 and 11: New stone staircase(right) leading to the East Wall of Lower Tiers of Zion. The Old gully (left) was full of loose rocks and was a major tripping hazard.

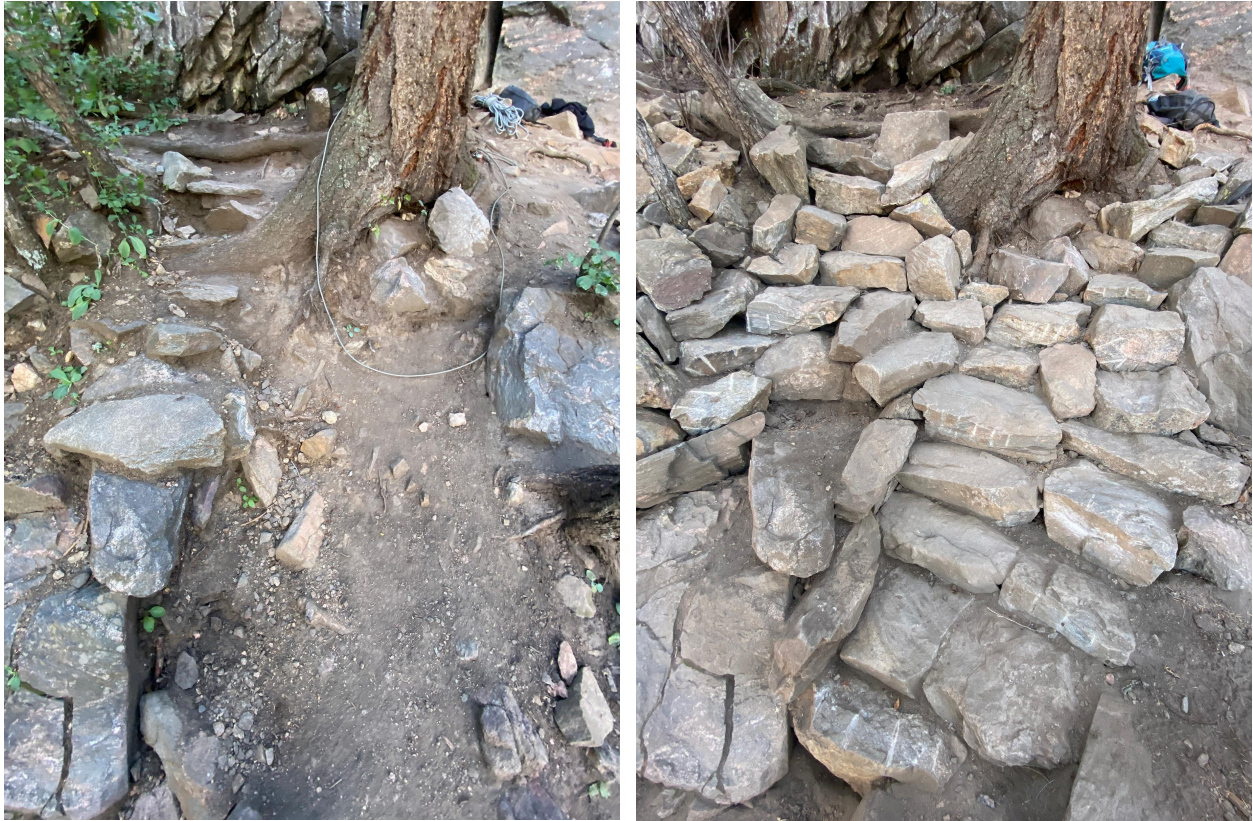
Figures 12 and 13: This is the highest trafficked area of the crag, which is the junction between the East Wall and main wall of Lower Tiers of Zion. The old eroding structure (left) was not built to withstand the traffic of the crag vs the new professionally built structure (right).

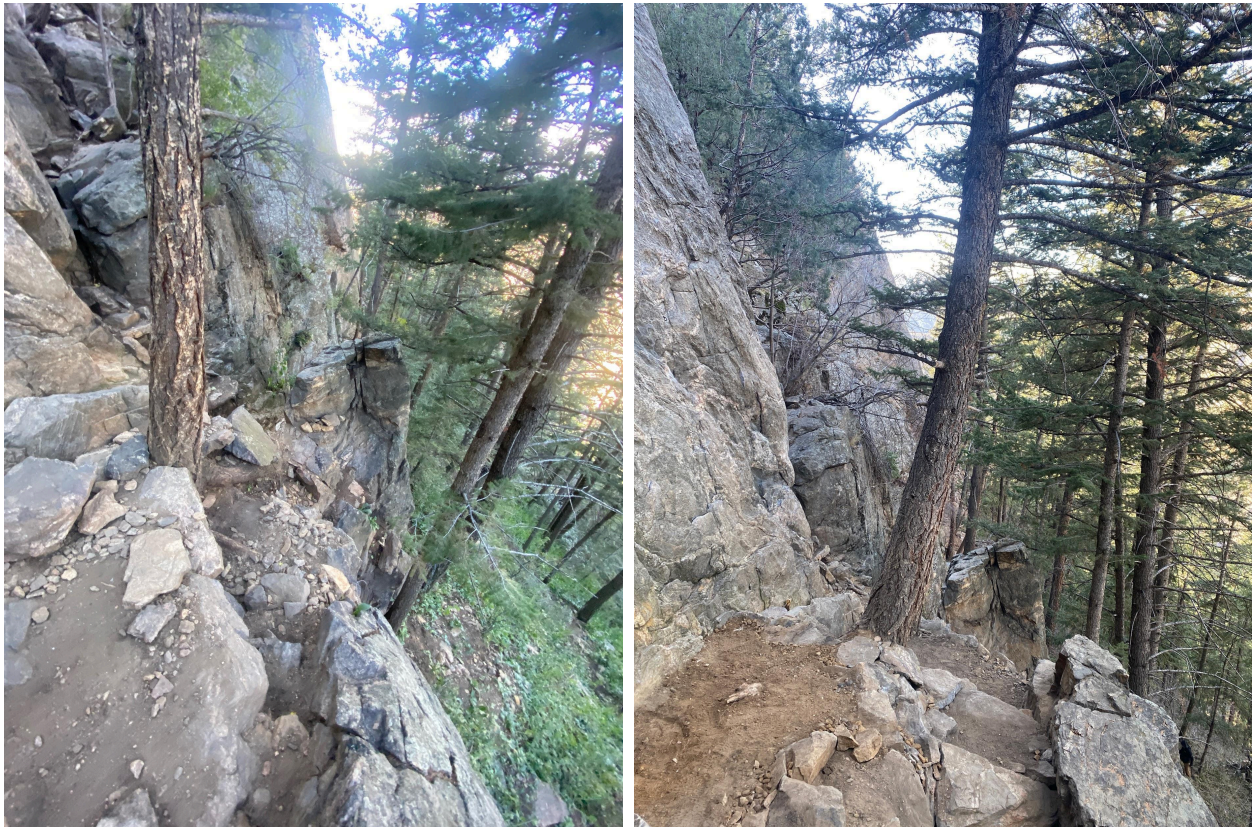
Figures 14 and 15: The base of the eroding East Wall (left) is now built up with a stone retaining structure and now has a large belay pad for the three climbing routes (right).
