The Front Range Climbing Stewards Plotinus Wall Erosion Mitigation Project Report

May 21st, 2017

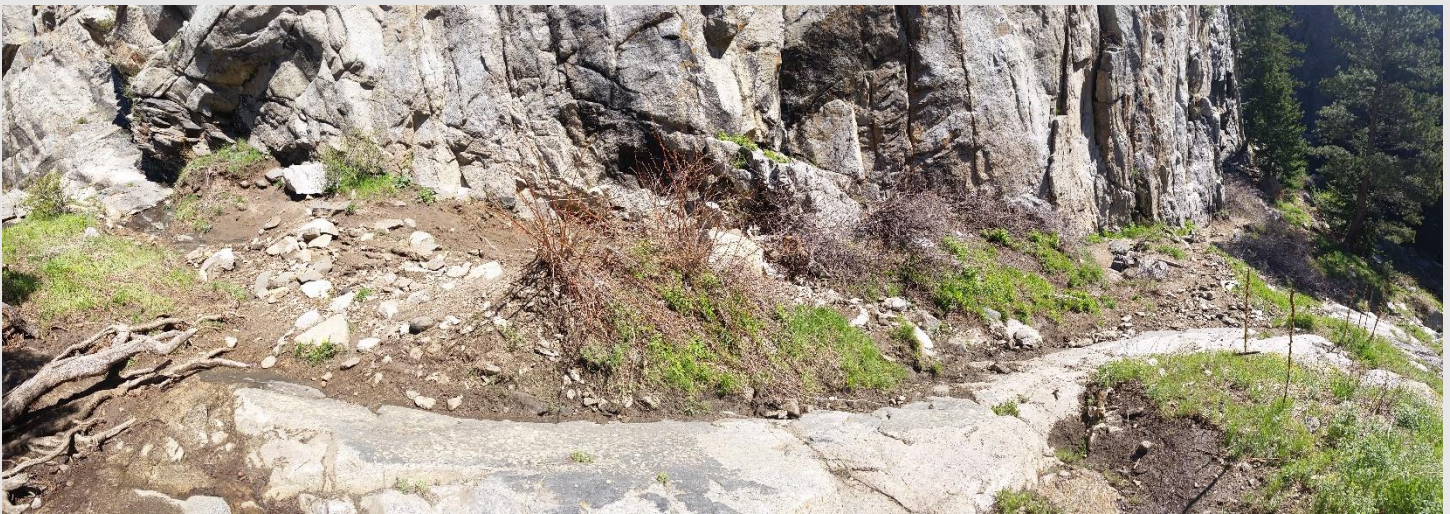
The slope at the base of the crag is steep and during storm events becomes an erosive gully (**Fig. 1 & 2**). With nearly 15 years of visitation to the area these steep slopes have lost their vegetation along much of the base of the approximately 200 foot long crag and show continued unnatural erosion. FRCS completed phase one of the project in June of 2016 and returned in March of 2017 to tackle phase 2.

Figure 1 - Erosive slope before

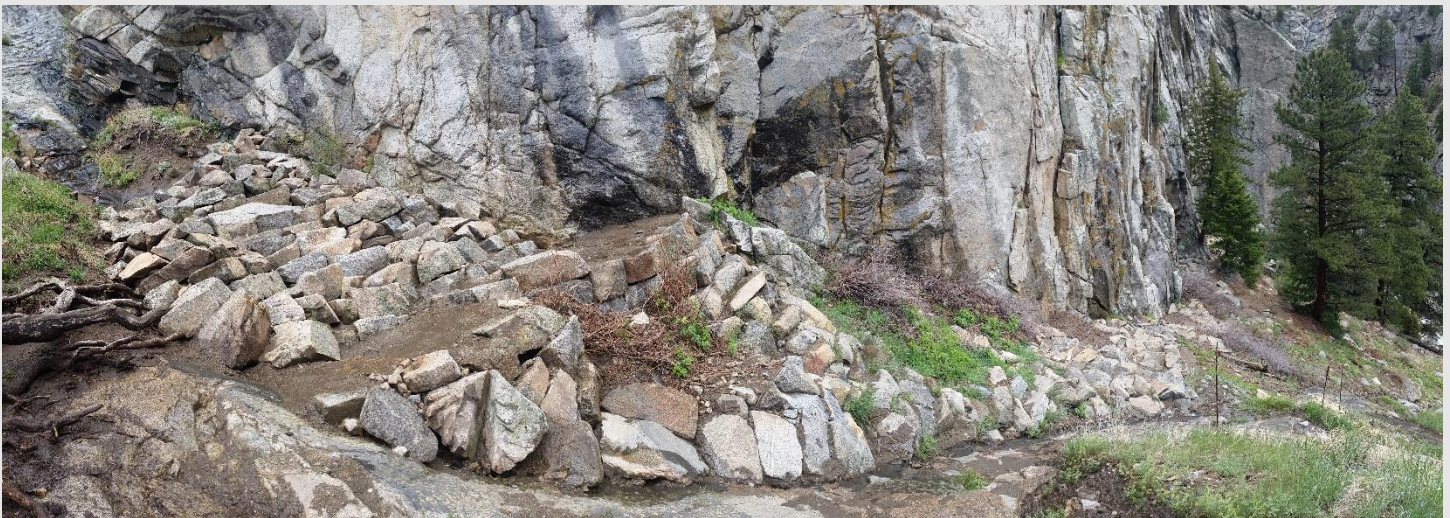
Figure 2 - Hardened Slope after

Approximately 625 square feet of stone structures were constructed at the base area of the Plotinus Wall during phase 2 of the project. These structures were designed and built to minimize the erosive impact of repeated foot traffic and water run-off. Consideration was given to the climbing use patterns of the crag and the water flows through it. The structures were constructed in a style that mimics a natural talus field (**Fig. 7**). Please see a detailed breakdown of the outcomes in the **Work Metrics** section below and a sampling of before and after photos of various worksites in **Appendix B**. Of particular note is that nearly every rock used in this phase of the project (greater than 620 cu. ft. of stone!) was transported twice via highline rigging systems to reach its place in the structures more than 40 meters away over steep and unmanageable terrain. This required much effort, time and advanced

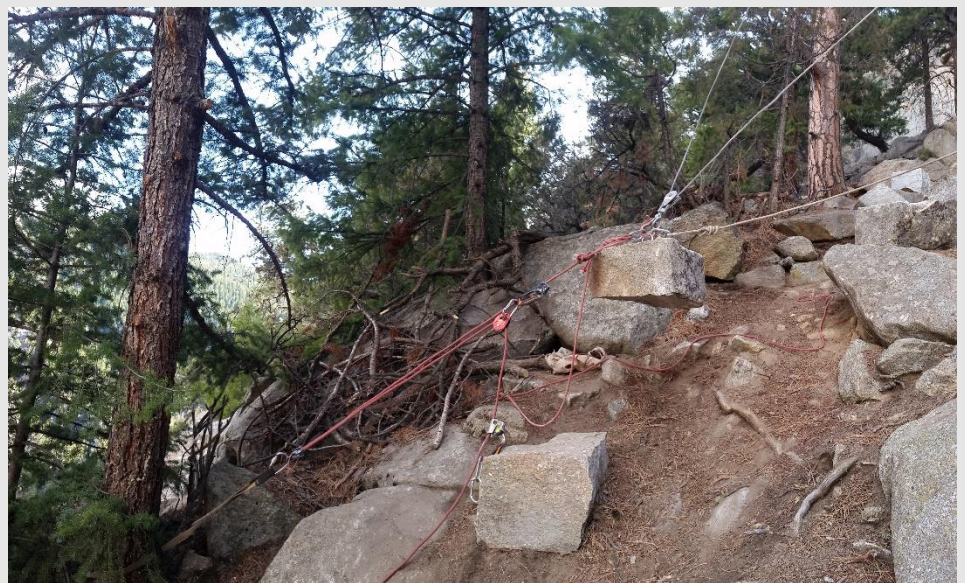
Figure 2 - Rigging Rock material into position

system was utilized to deliver this mass to the worksites (**Fig. 3 & 4**). Once the material was located at the worksites FRCS utilized the stone to build erosion control structures and hardened surfaces at the base of the cliff (**Fig. 5 & 6**). All labor for the project was provided by the FRCS crew and volunteers trained and supervised by the crew. A total of 1626.2 hours were logged on phase 2 of this project: 1473.2 hours of paid labor and 153 hours of volunteer labor. This makes a cumulative total of 2108.2 hours of labor devoted to this project over the last two years. For a detailed list of labor hours see **appendix A**. In addition to labor, approximately 90 hours of Planning and Development time has been dedicated to this project since inception. The Boulder Climbing Community fundraised to support this professional crew as well as the project's design and management. REI Colorado generously provided the funding for this project

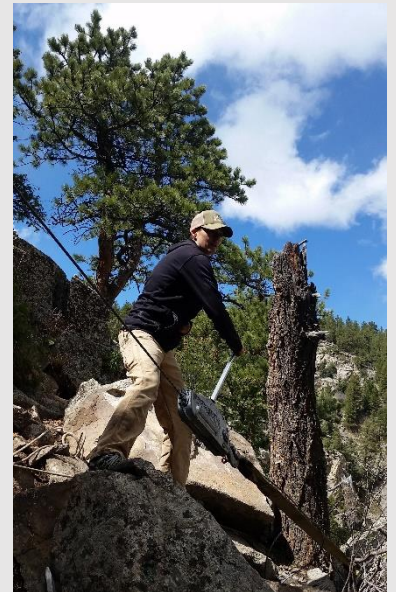
Figure 4 - Tensioning highline

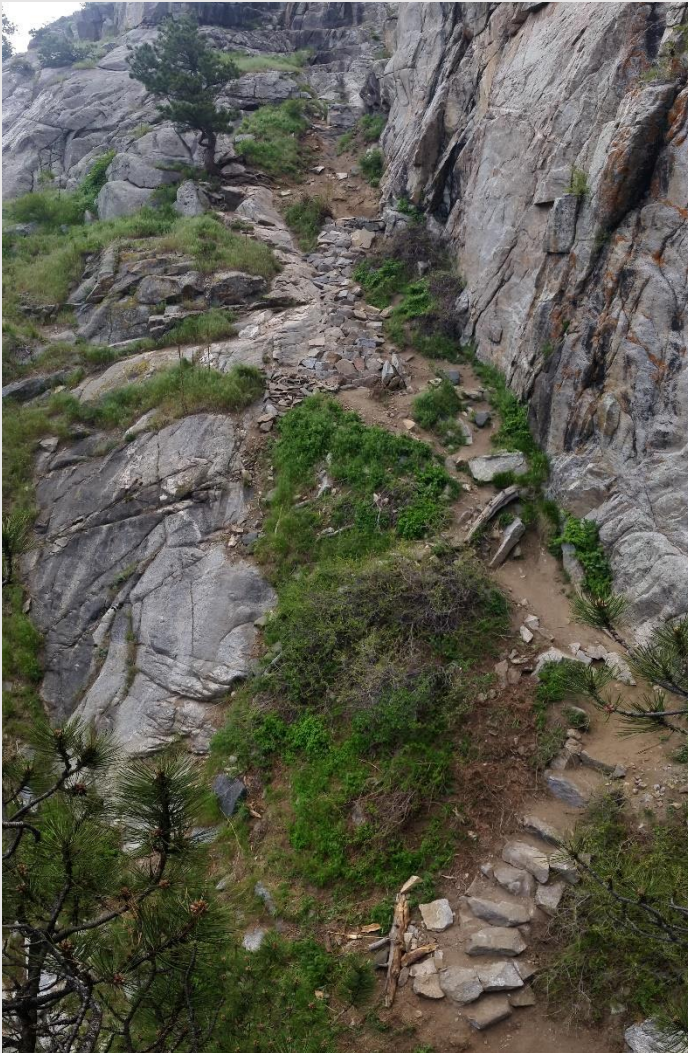
Figure 5 – Before photo, taken June 20th 2016

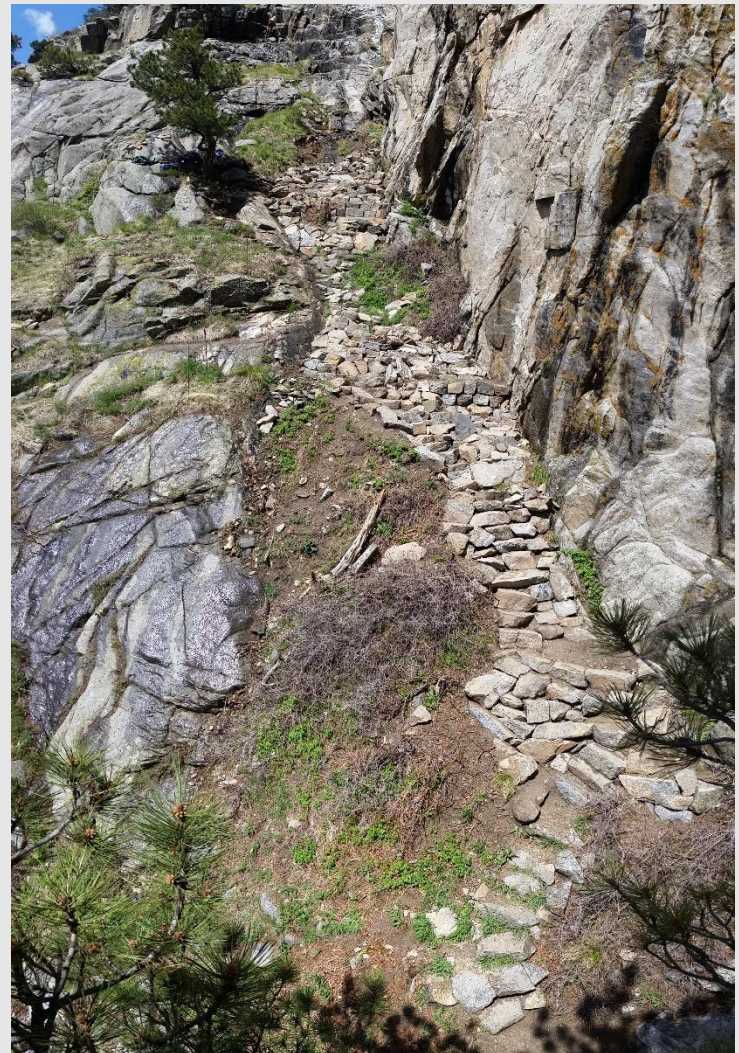
Figure 6 – After photo, taken May 11th 2017

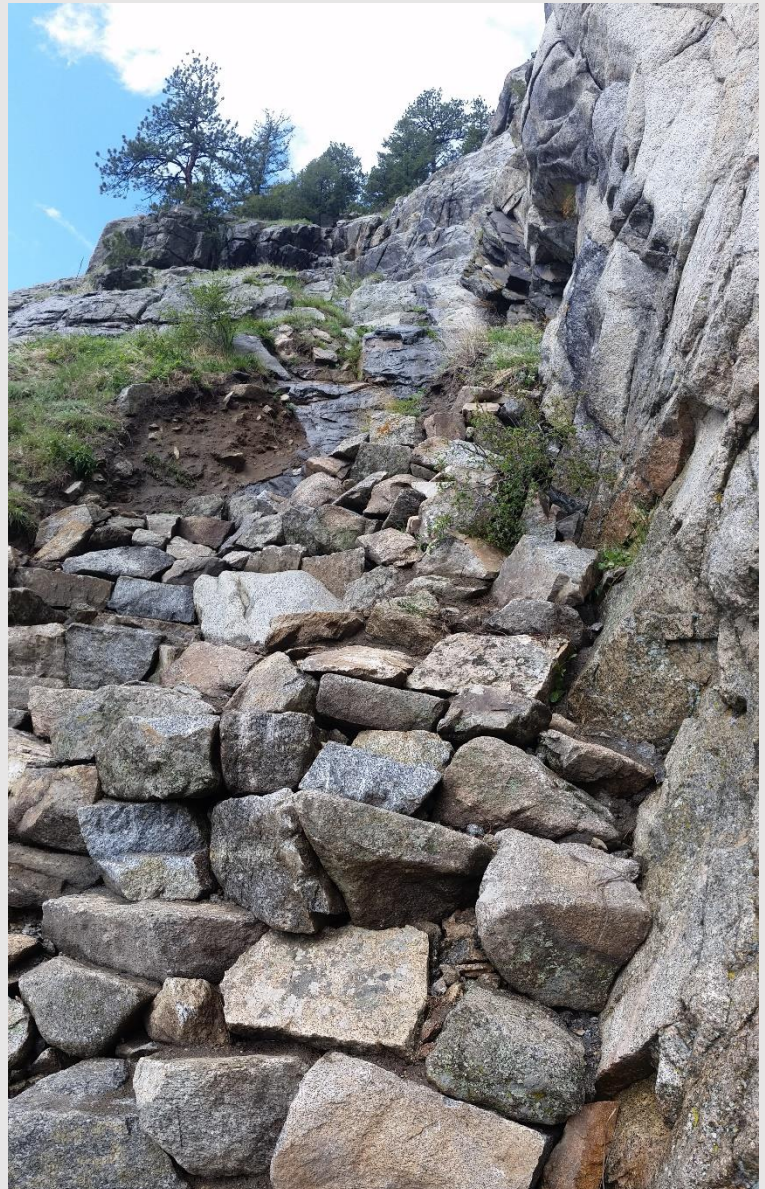
Figure 7 - Arranged talus construction
