The Front Range Climbing Stewards Plotinus Wall Erosion Mitigation Project Report

July 28, 2016

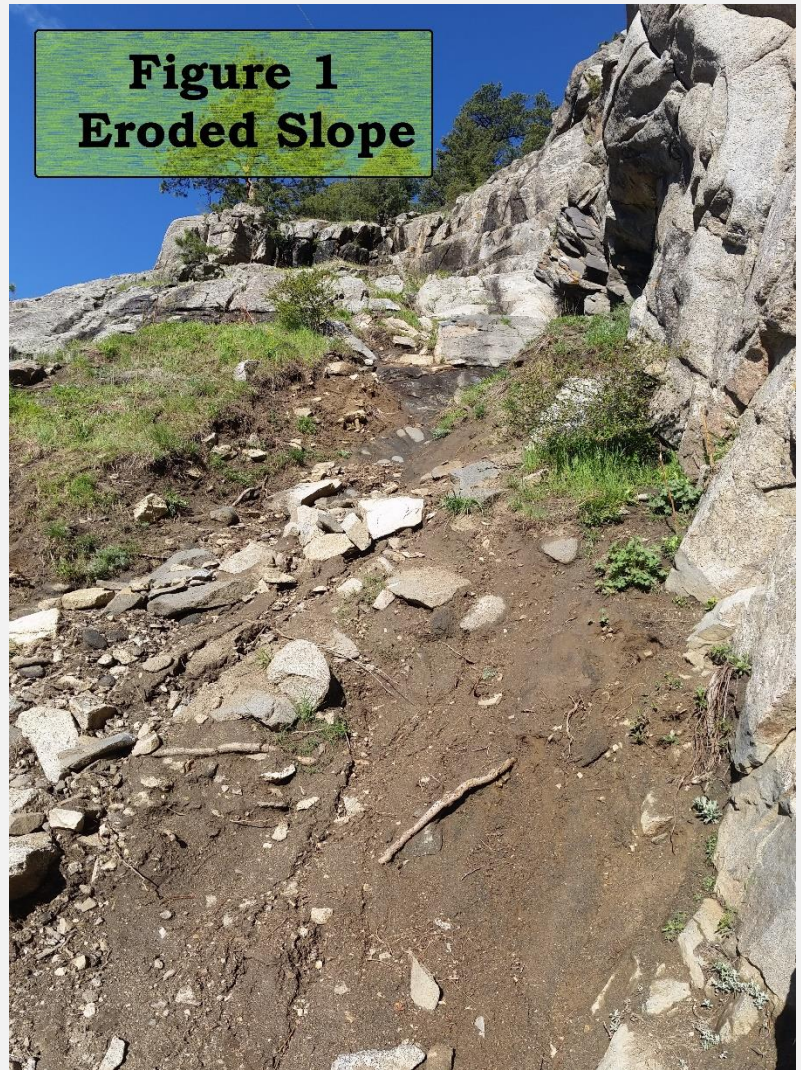
Figure 1
Eroded Slope

The slope at the base of the crag is steep and during storm events becomes an erosive gully. With nearly 15 years of visitation to the area these steep slopes have lost their vegetation along much of the base of the approximately 200 foot long crag and show continued unnatural erosion (**Fig. 1**). FRCS proposed to the Boulder Ranger District a stewardship project of mitigating the erosion along the cliff base and was given the charge of implementing the project.

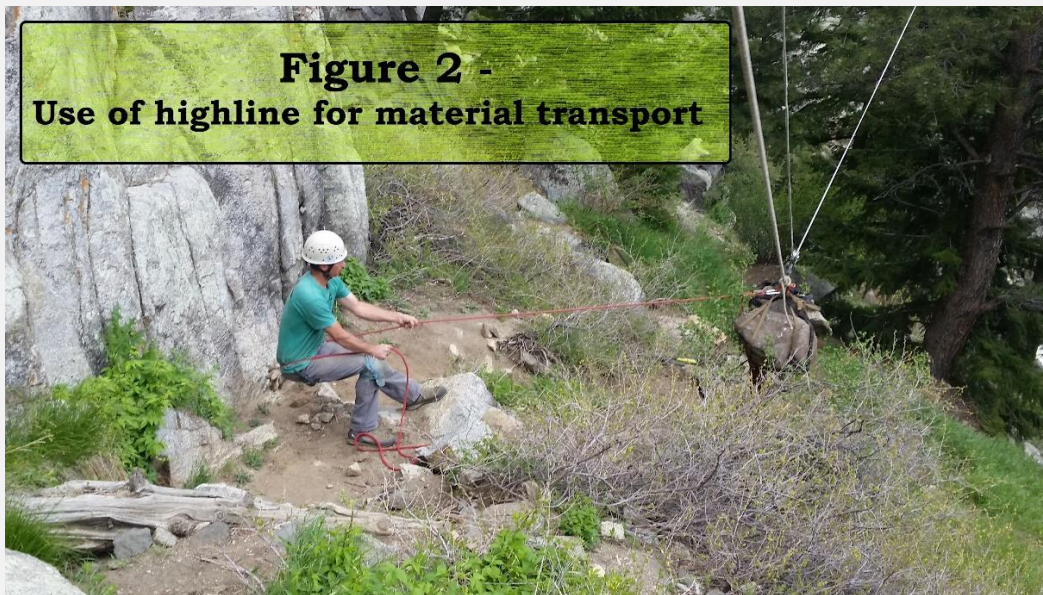
Figure 2 -
Use of highline for material transport

The project was scheduled for 3 weeks in June 2016 and design and project implementation strategies were vetted by the USFS. An agreement was coordinated with Boulder City Open Space and Mountain Parks to provide access through Boulder Falls for the construction. A strategy was set to construct stone structures along the affected areas that will dampen the flow of water and provide hardened surfaces where climbers access the cliff. This strategy required a considerable quantity of stone material to build the structures. Rock material was quarried above the wall and a highline rigging system (**Fig. 2**) was utilized to deliver this mass to the worksites

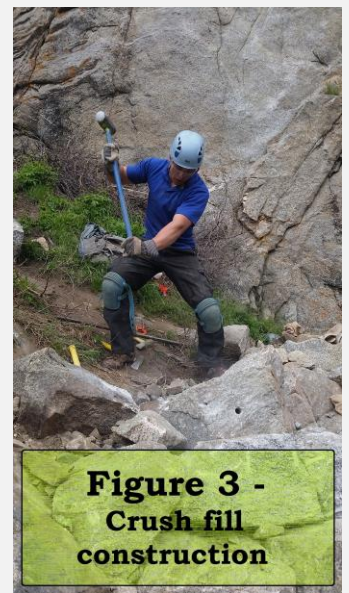
Figure 3 -
Crush fill construction

Approximately 245 square feet of stone structures were constructed at the base area of the Plotinus Wall. These structures were designed and built to minimize the erosive impact of repeated foot traffic and water run off. Consideration was given to the climbing use patterns of the crag and the way that water flows through it. The structures were constructed in a style that mimics a natural talus field (**Fig. 5**). Great care was taken to pack crush fill behind the entirety of the structures in order to allow water to drain through the site in as slow and controllable manner possible (**Fig. 3**). Please see a detailed breakdown of the outcomes in the **Work Metrics** section below.

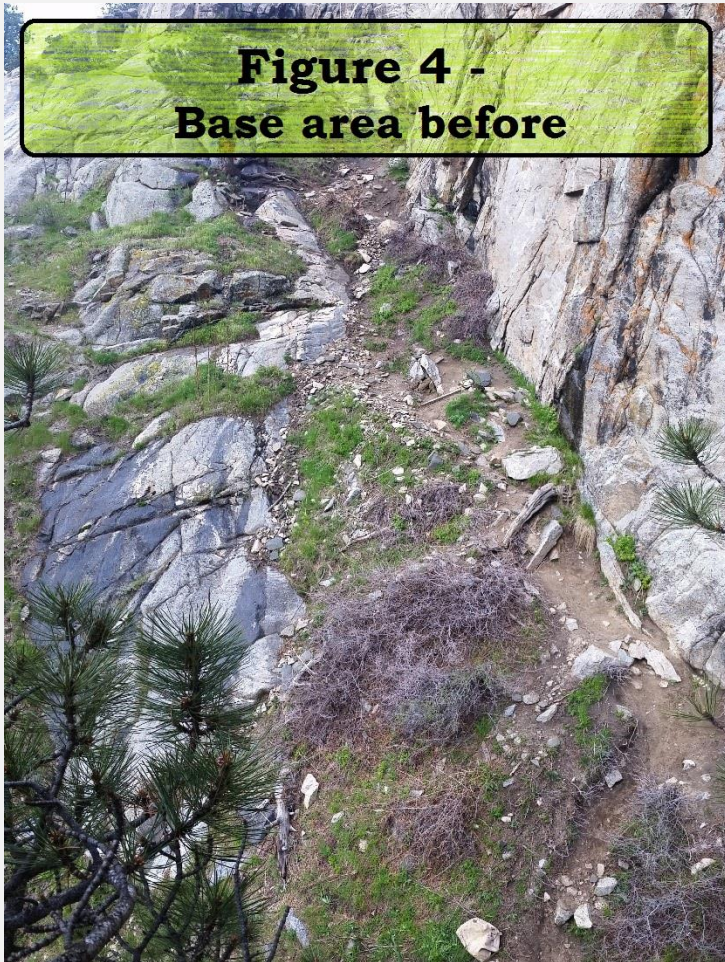
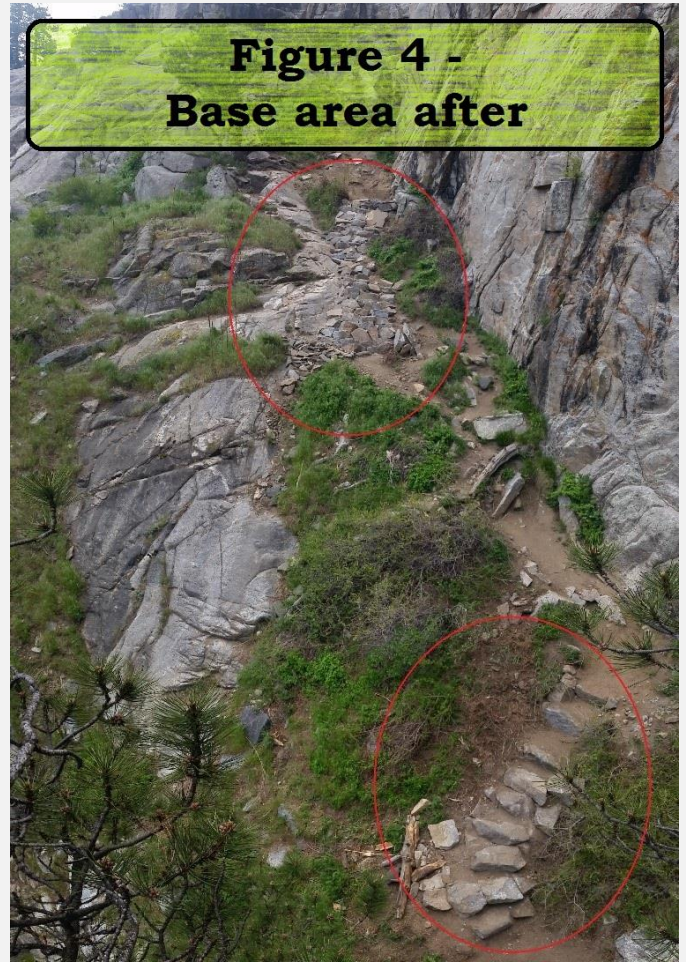
Once the material was located at the worksites FRCS utilized it to build erosion control structures and hardened surfaces at the base of the cliff (**Fig. 4, before & after**). All labor for the project was provided by the FRCS crew and volunteers trained and supervised by the crew. A total of 482 hours were logged on this project: 419 hours by the paid crew and 63 hours by volunteers. For a complete list of labor hours see **appendix A**. The Boulder
