The Front Range Climbing Stewards Scarface Approach Trail Project Report

March, 2019

Overview of the 2019 Scarface Trail Maintenance Project:

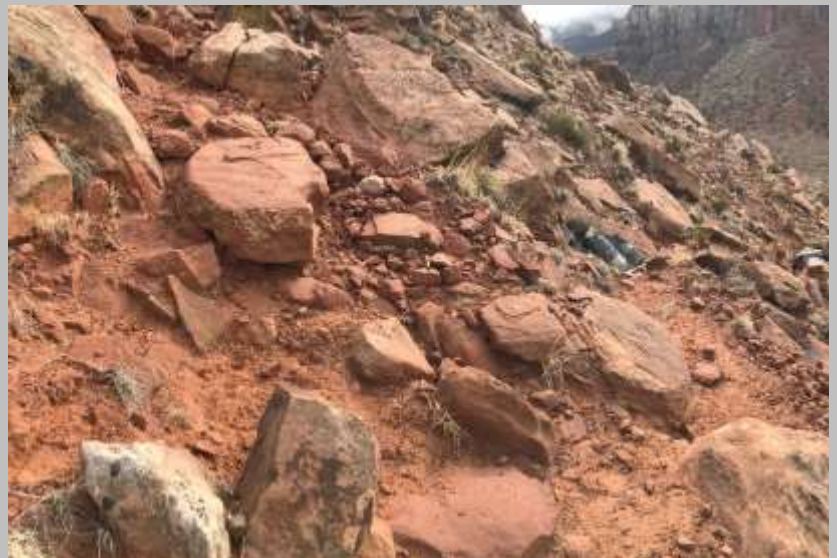
Figure 1 - Loose and eroded access trail to Scarface Wall

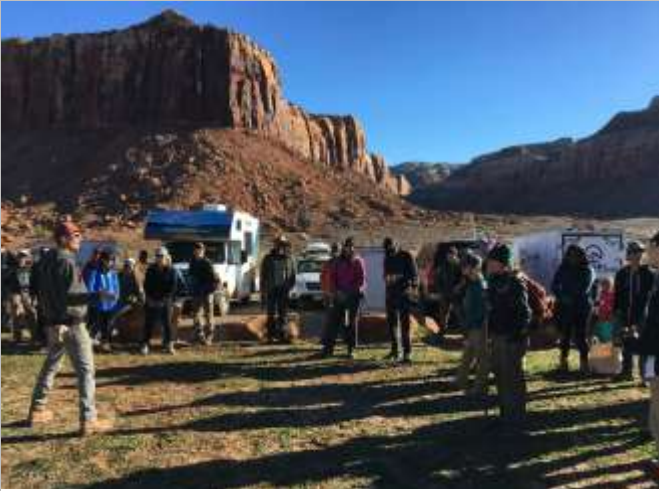
Volunteer orientation - 606 vol. hours were leveraged

Figure 2,3,4 & 5 – Examples of the variety of skilled and volunteer work that comprised this project

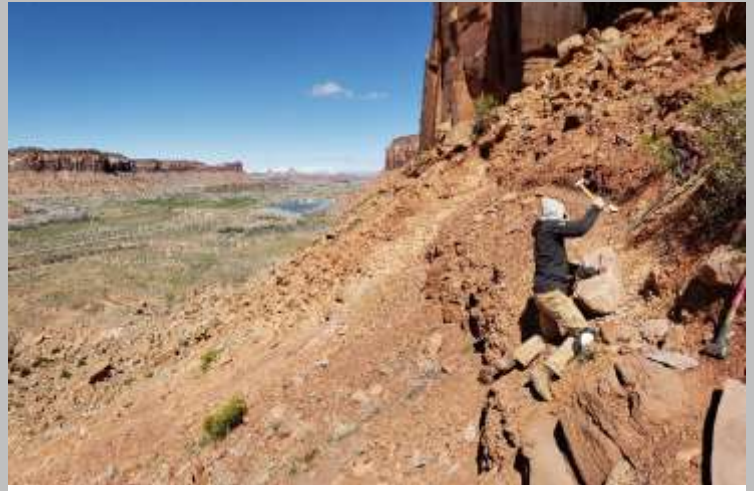
Skilled and at times, exposed rock work – 540 professional hrs of labor

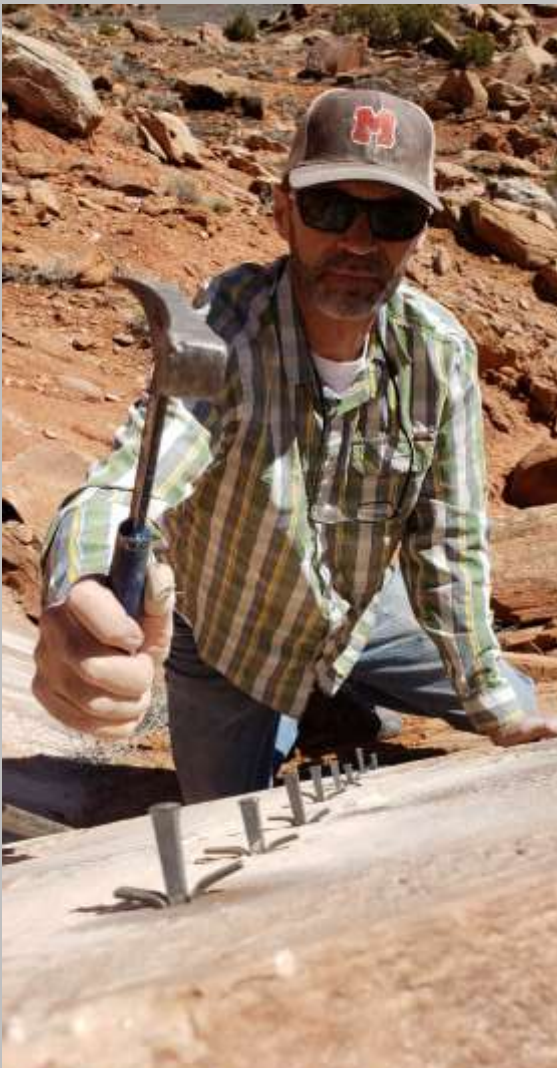
Stone Quarrying – 273^{3ft} of stone was quarried on site

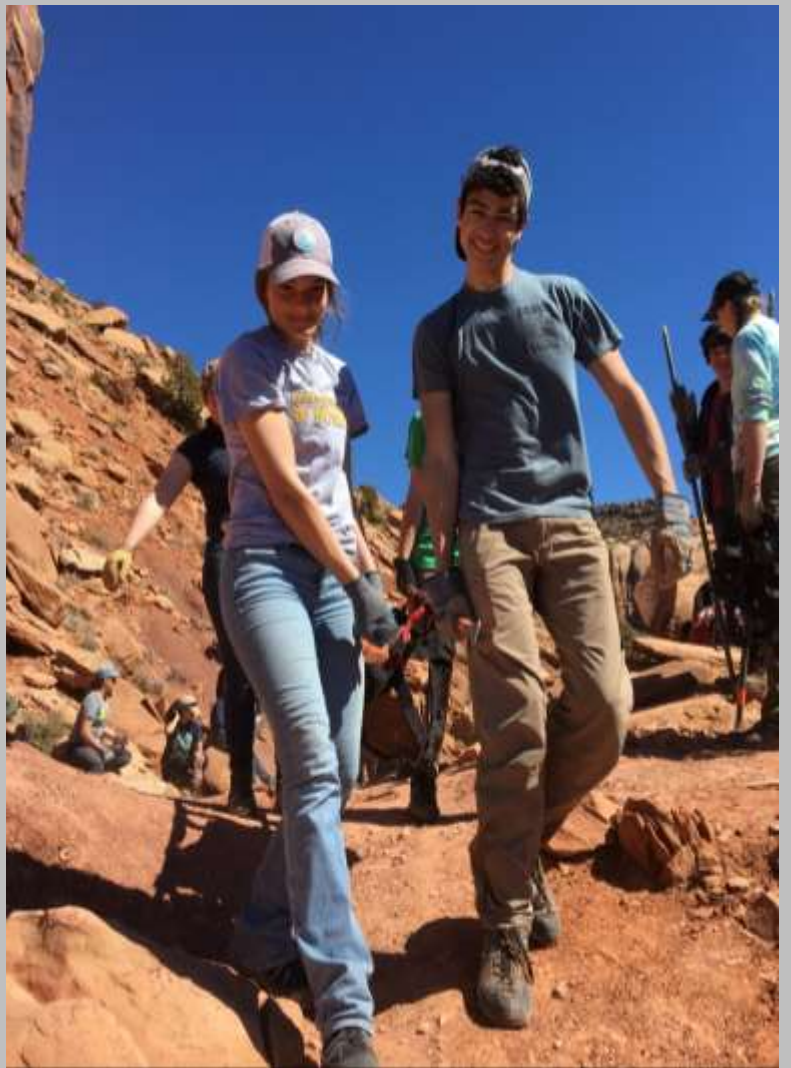
Manual stone transportation – 449 stones were transported to worksites
