### 2022 Hillbilly Rock Climbing Access Project Report

### Overview

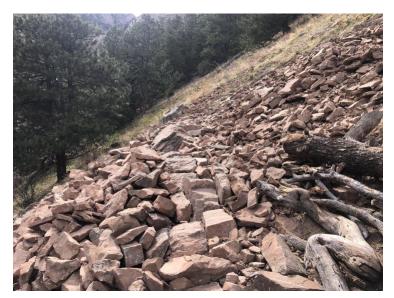
Figure 1: Paving stones were used to gain trail height versus a more traditional stone staircase.

Hillbilly Rock trail being undesignated, trail work structures such as staircases had to be minimal and blend into the hillside. BCC's Trail Program rerouted a portion of the trail, constructing most of the trail in an adjacent talus field and laying stones down in a "paving" fashion to gain trail height versus a more traditional stone staircase approach (**Figure 1**). In addition to BCC's trail

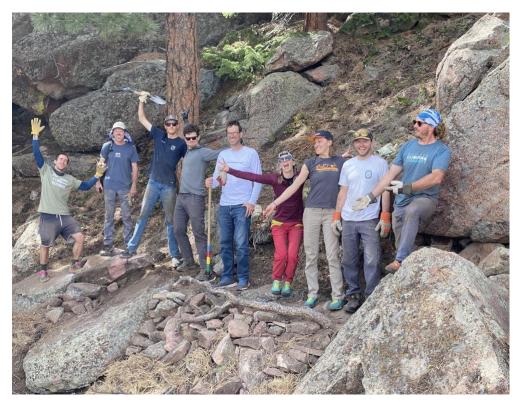
Figure 2: Volunteers built the upper portion of trail that funnels downhill traffic towards the top of the Hillbilly Rock

staff, various volunteer groups assisted with the work during volunteer trail days (**Figure 2**). The labor and planning for this project can be found in **Appendix A**.
