The Front Range Climbing Stewards Mt. Glennon Darkside II Project Report

May 2nd 2016

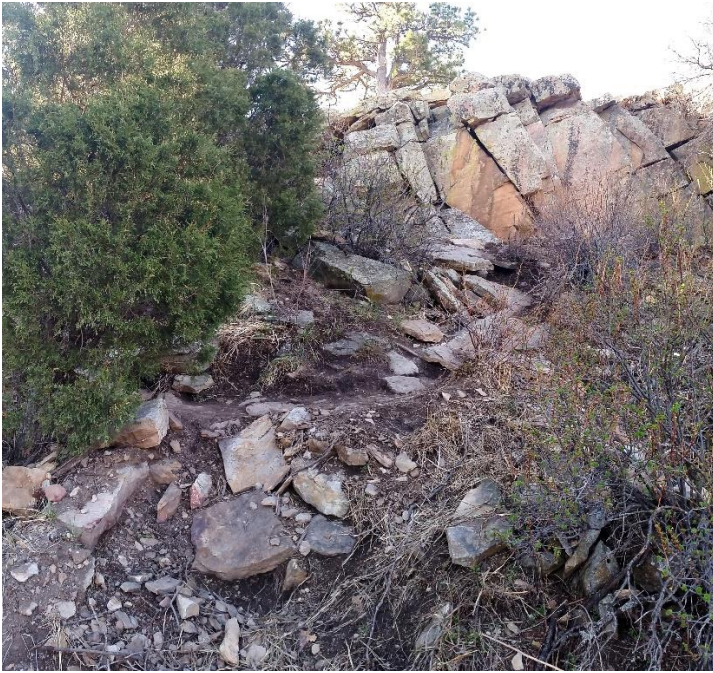
Trail before

loose eroded shoots. The construction involved building stone staircases and check steps into the unsustainable user trail along the existing trail corridor. In addition to this objective FRCS installed a staircase and improved two landing platforms off of this main trail where further erosion could be prevented and the safety of climbers could be improved. Delineating and amplifying the connection of the trail to the Mt. Glennon ridge above the bouldering areas was performed in line with the strategy of discouraging the use of the numerous social trails between the ridge and the trailhead.

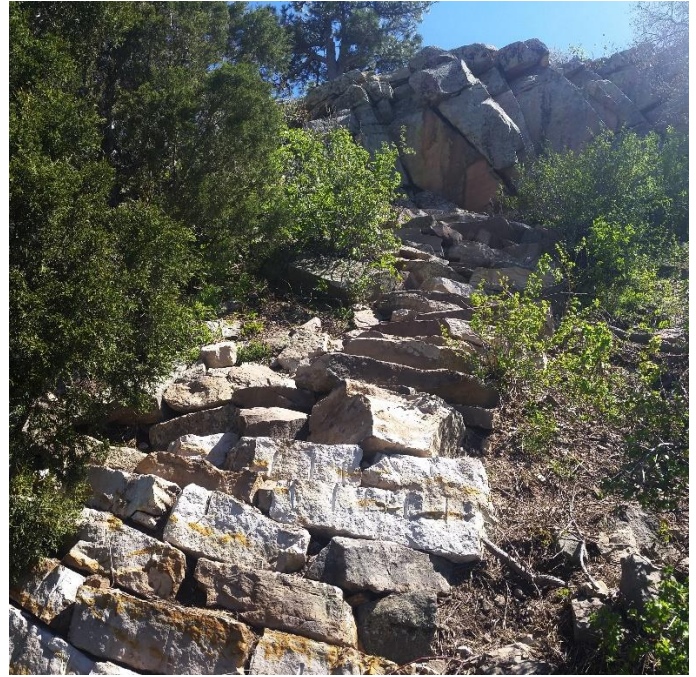
Trail after

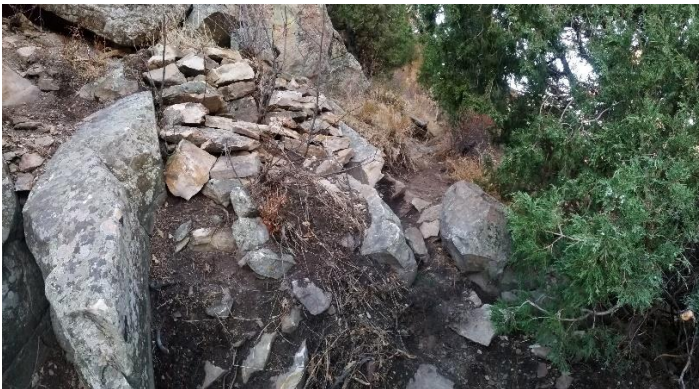
Trail before

The method of quarrying the stone material needed for these structures from the slopes above and then restoring these quarry sites allowed relatively small FRCS crew to complete the project within seven weeks. The effected slopes were restored and protected by retaining structures with natural character. The skilled stone work was performed by four FRCS crew members with occasional help of 17 volunteers from the climbing community. Earthtreks-Golden climbing gym in particular supported the project by sending paid staff to volunteer one day. For a list of volunteers & metrics see appendix A.

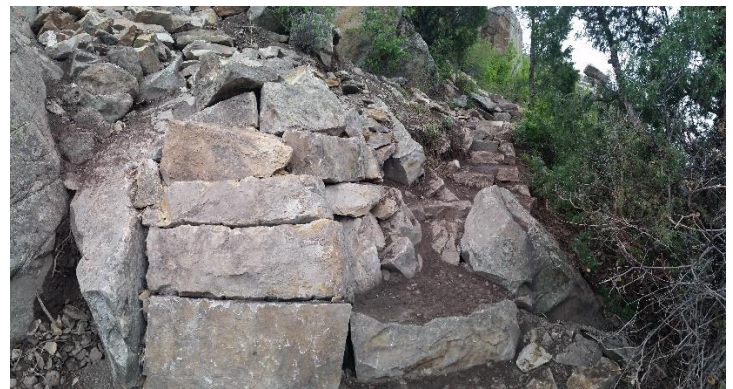
Trail after
