Staunton State Park The Dungeon Climbing Area 2022

Overview

The Boulder Climbing Community's (BCC) Trail Program has completed a three-week trail work project on the Dungeon Climbing area in Staunton State Park. The primary objective for this project was to shift the existing trail away from the base of the climbs and stabilize the talus field which the trail resides in.

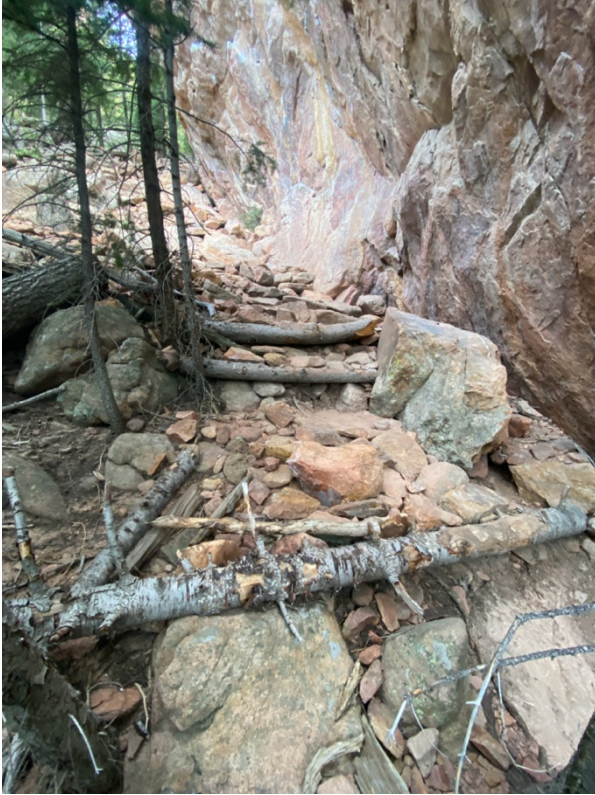
Figure 2: Entrance way to the Dungeon. Before

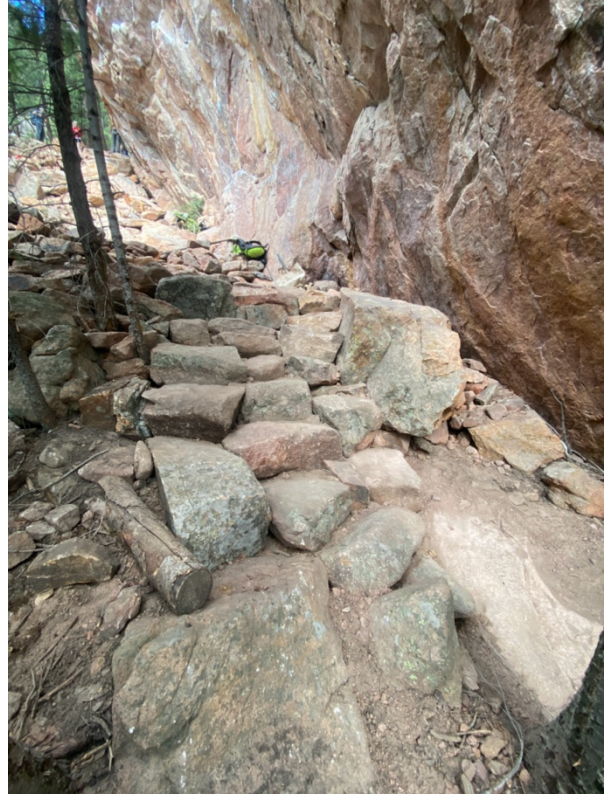
Figure 3: Entrance way to the Dungeon. After

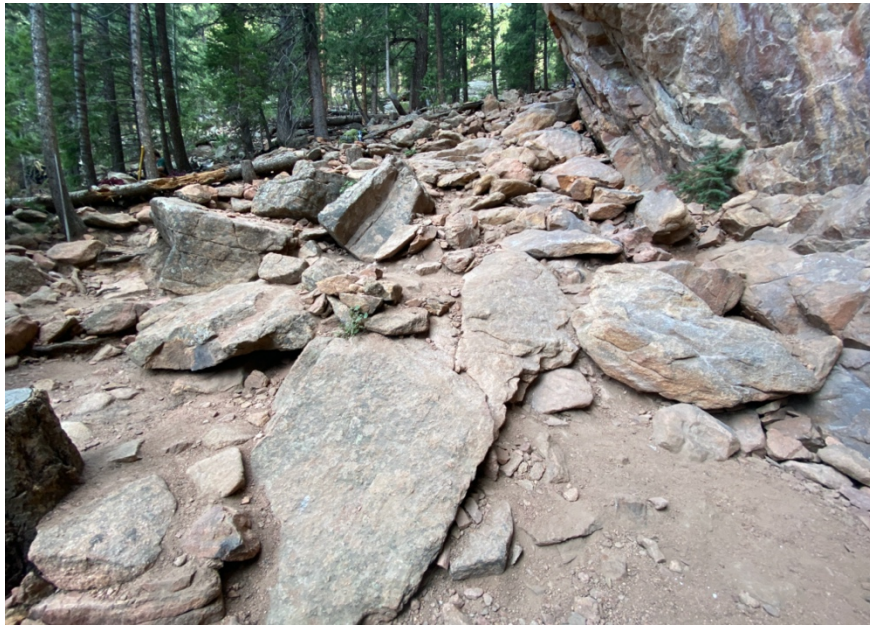
Figure 4: Low section of the Dungeon. Before

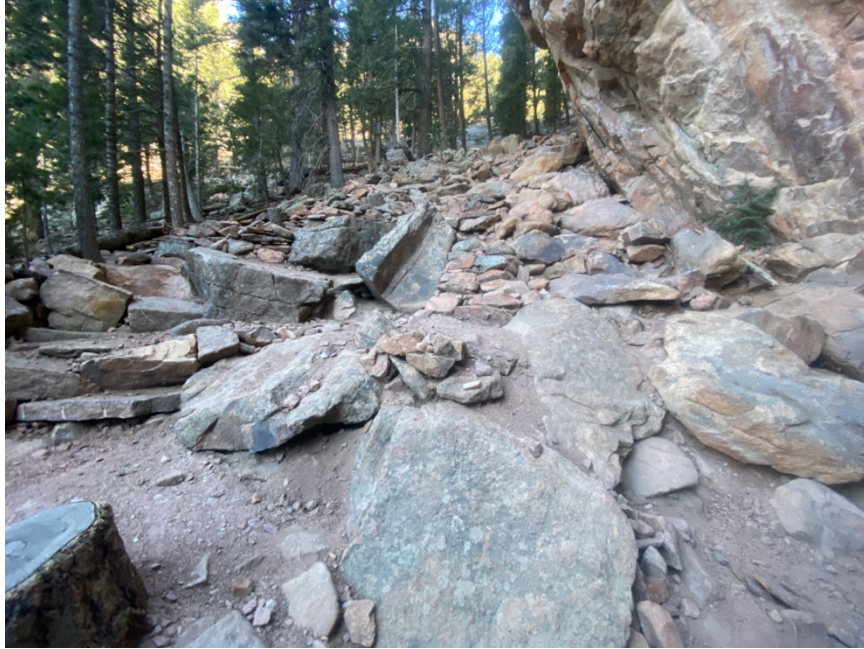
Figure 5: Lower section of the Dungeon with added belay pads under the wall and trail to the left. After

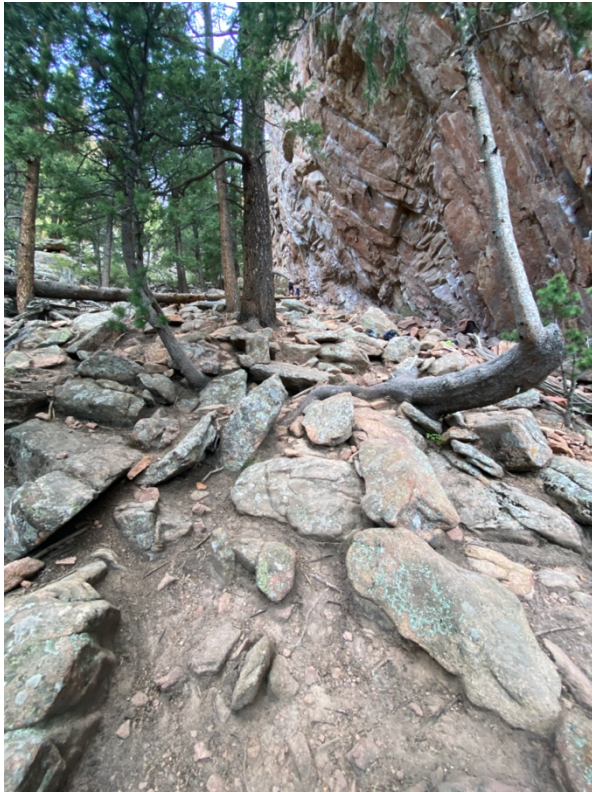
Figure 6: Rough trail to the left of the Dungeon. Before

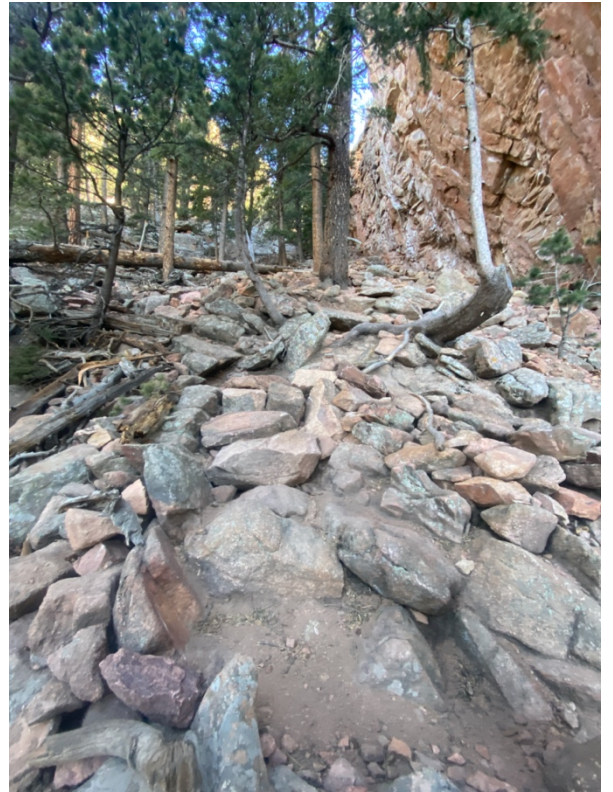
Figure 7: Stone steps replacing the rough terrain. After

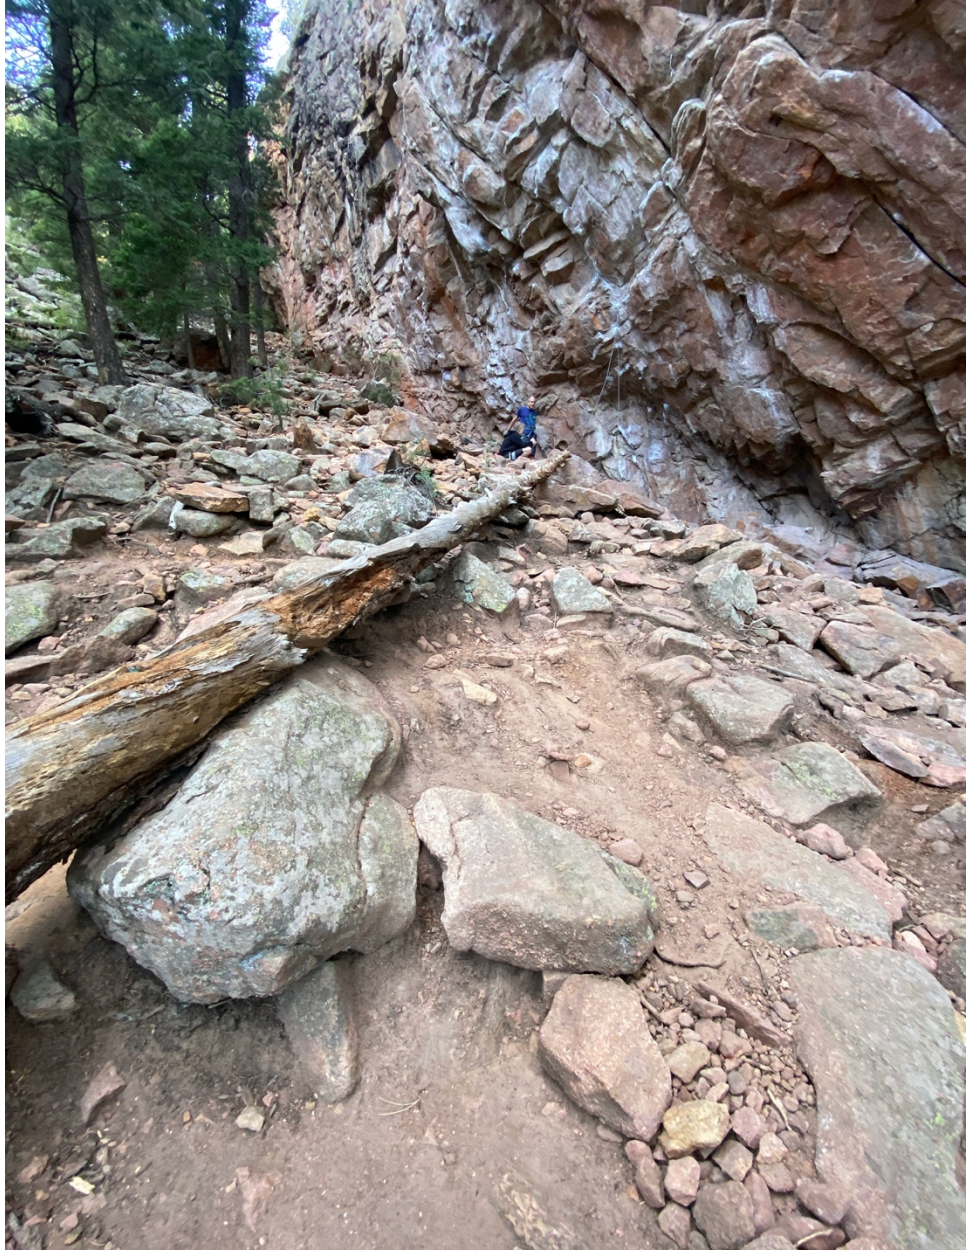
*Figure 8: Large fallen tree blocking a path forcing hikers to walk under the climbing wall.
Before*

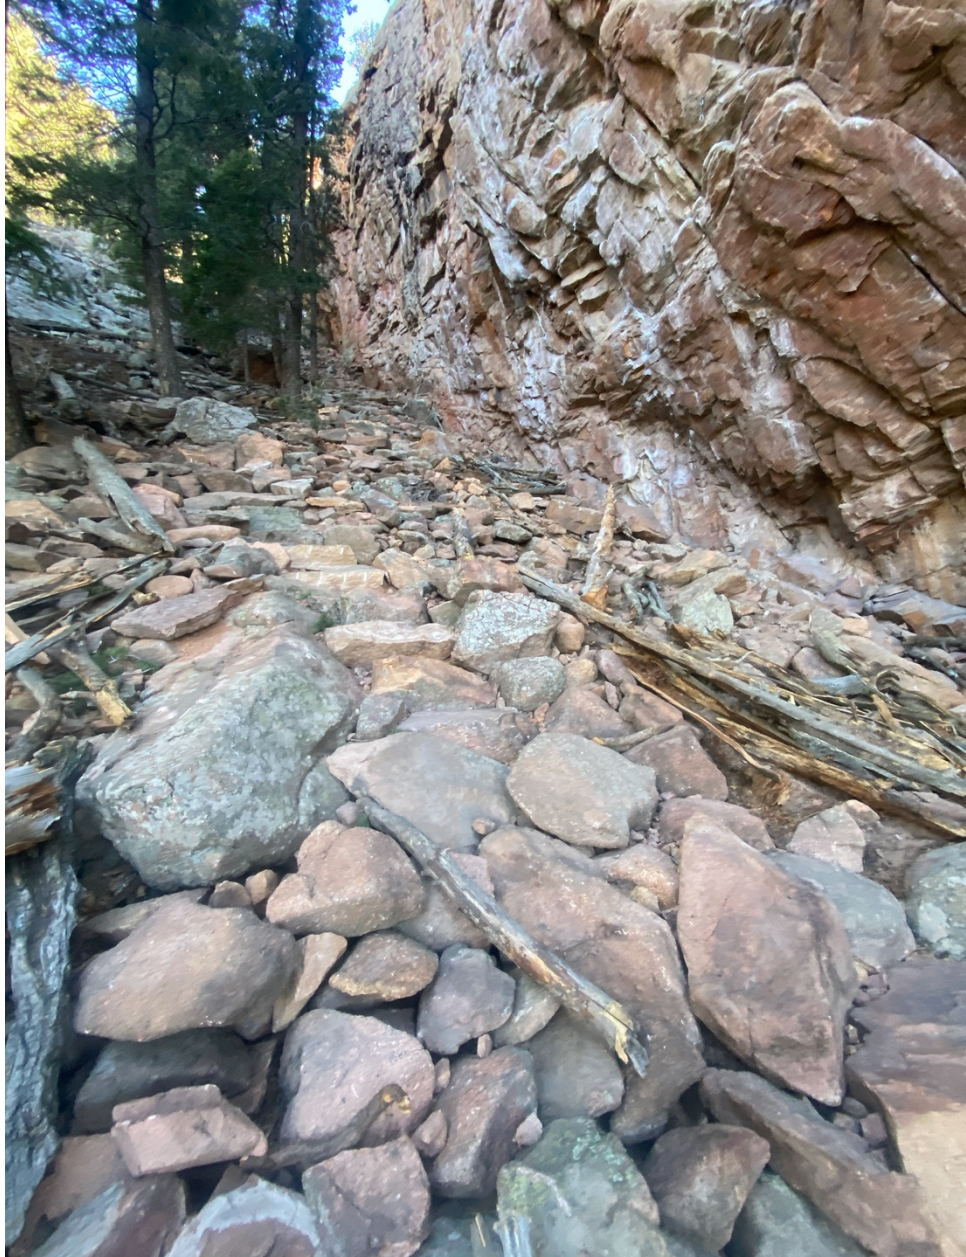
Figure 9: Fallen log removed and replaced with a hardened stone path with a mixture of stone steps and pavers allowing hikers a path that is not under the wall and climbs. After

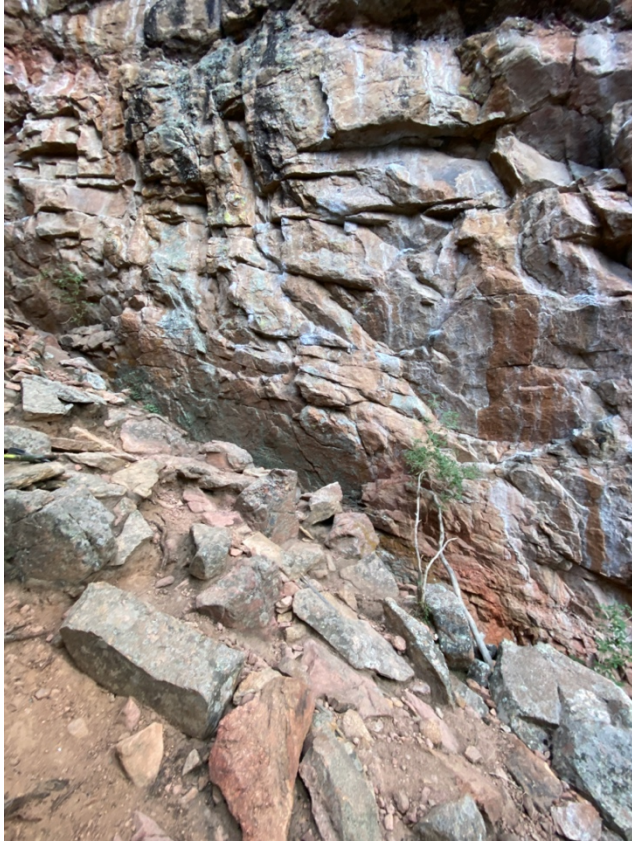
Figure 10: Belay area under a popular route Unshackled 5.10+. Before

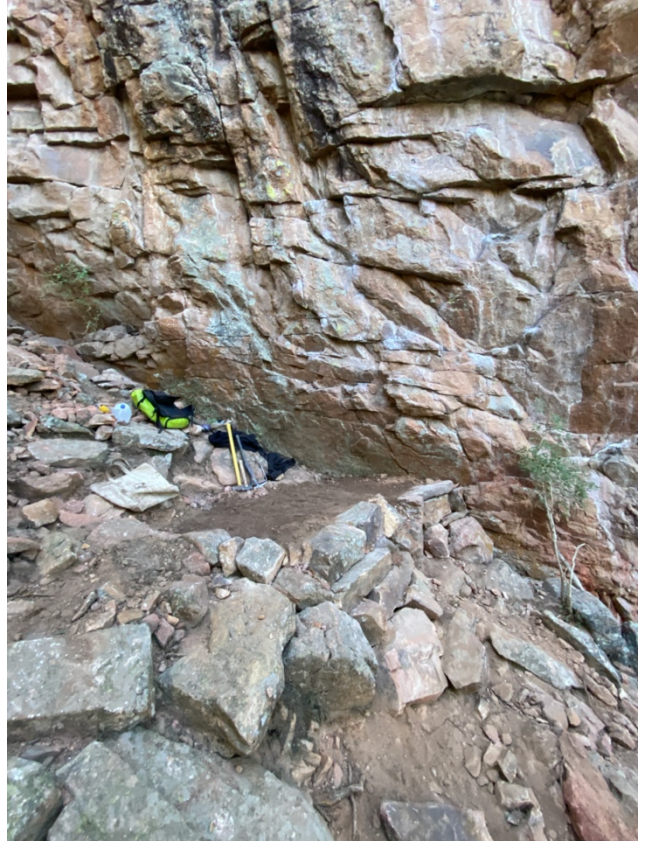
Figure 11: Belay pad constructed with retaining structure. After

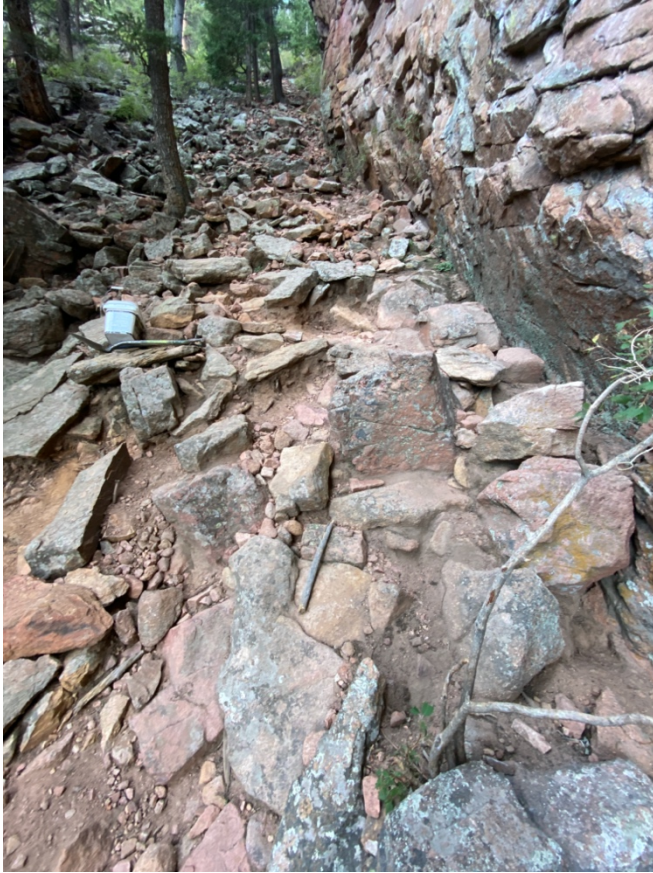
Figure 12: Another view of the unstable belay area under Unshackled 5.10+. Before

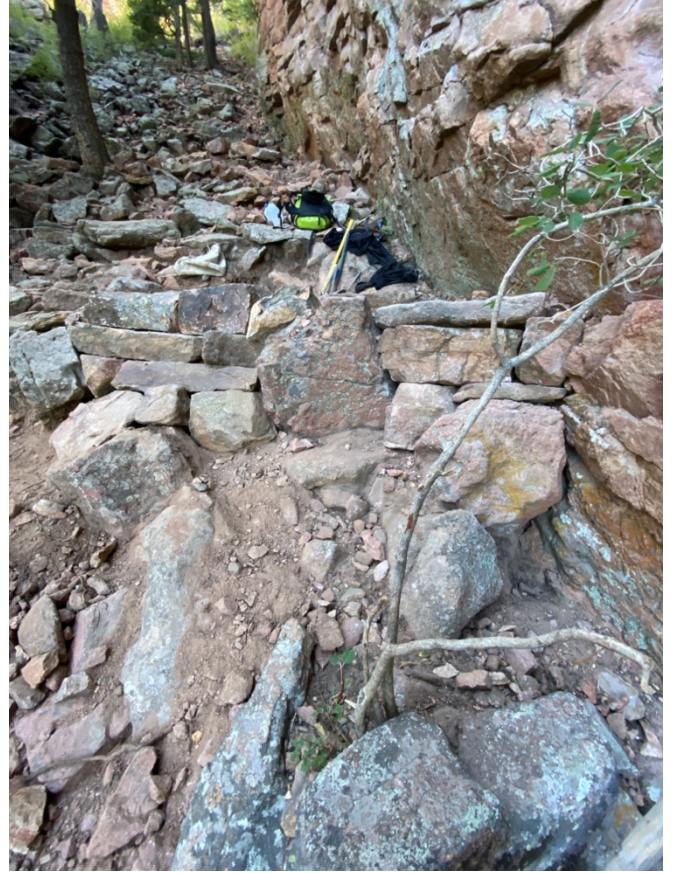
Figure 13: Retaining structure for the belay pad incorporating existing solid stone. After
