# The Front Range Climbing Stewards

## Turkey Rocks Approach Trail Project Report

Oct. 9<sup>th</sup> 2015

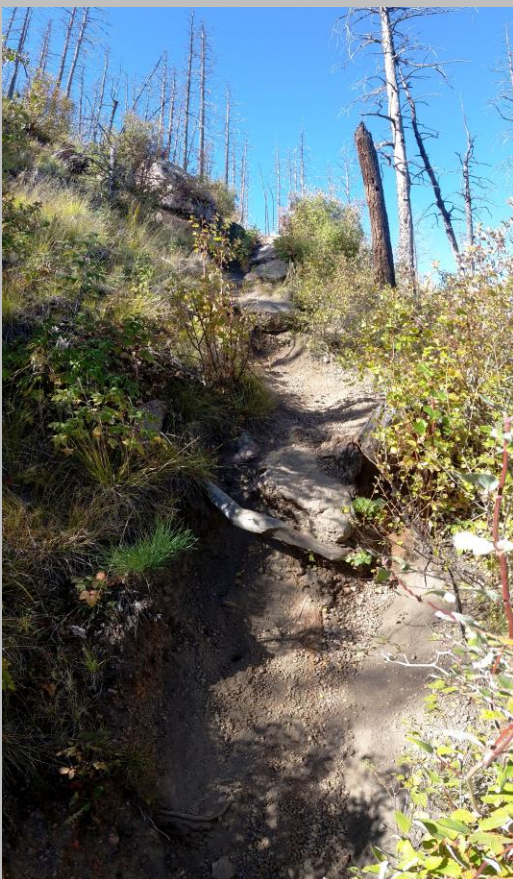
Figure 1 (before & after)

The stone structures (**Figures 1 & 2**) were composed of steps and retaining structures that were designed/built with erosion mitigation in mind. The log check dams were built in response to the rills that have formed as a result of the trail alignment/structures of the past (**Figure 3**). The quarrying of stone material took place in the surrounding areas and transported via man-power to the worksites. The dead and down timbers that were used for the erosion mitigation, were partially buried and staked down with native timbers of appropriate size.
